MINISTRY OF TRANSPORTS AND INFRASTRUCTURE
ROMANIAN RAILWAY AUTHORITY - AFER

INVESTIGATING REPORT

on the railway incident
occured on the 8th of September 2009 in the railway station Ilva Mică

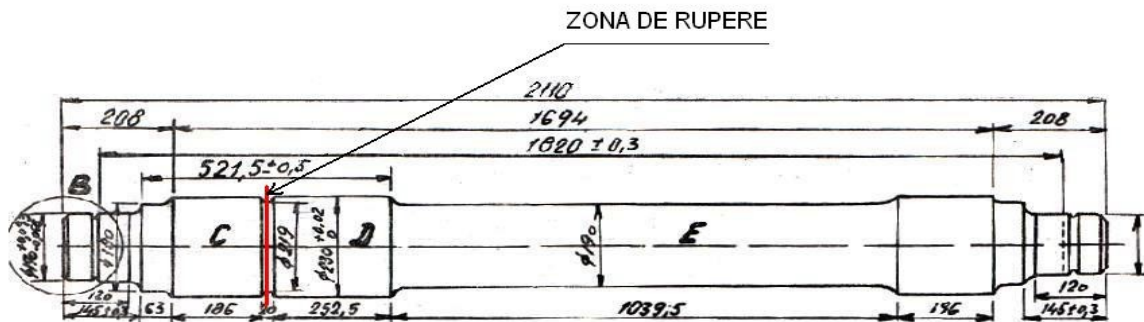
Drawing no. 1

- the toothed wheel and the drive pinion didn't have the teeth affected and didn't show any signs of pitting;
- the oil in the gear drum was in an appropriate amount and didn't contain any metallic filings;
- the bearings supporting the gear drum didn't have the tendency to lock, without clearance and without abnormal noise;
- the axle breakage happened at 402 - 408 mm from the axle head, perpendicularly on its longitudinal axis, on the connection between the wheel-seat area of the wheel membrane on the gear side (C) and the wheel-seat area of the toothed wheel (D) (drawing no.1);

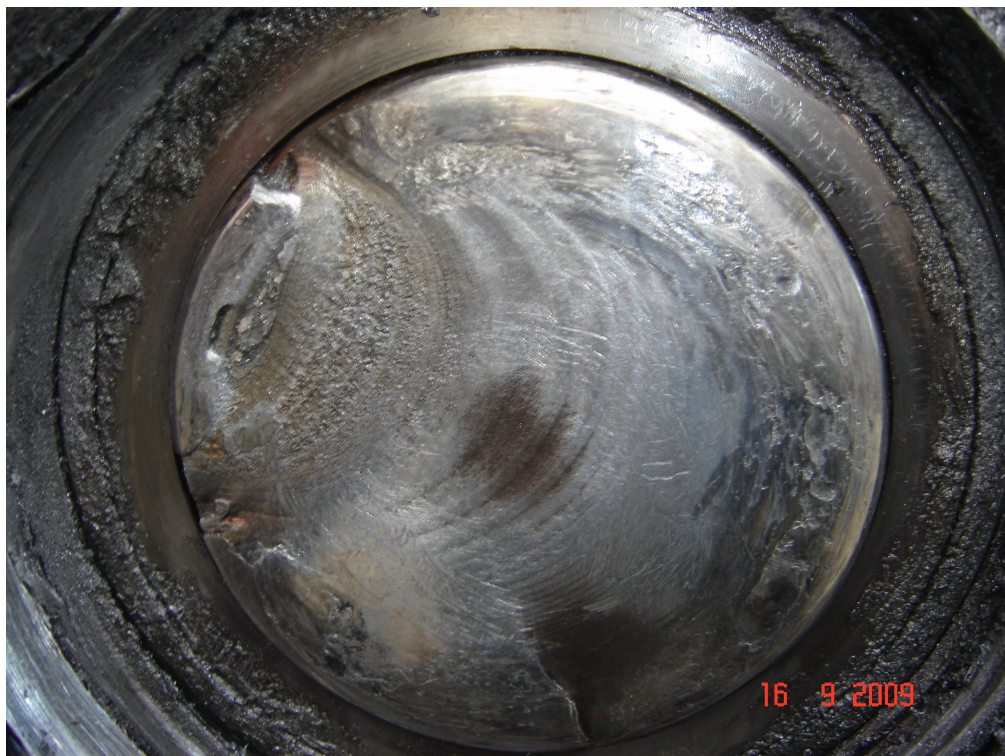
Photo nr. 1

- the weld size shows two distinct areas (photo no. 1) :
 - a specific area with fatigue fracture representing about 80 % of the breaking section;
 - an area with sharp breaking aspect, with material pluck representing about 20 % of the breaking section;

- ultrasonic control;
 - penetrating liquid control;
- from these tests and examinations the followings were found out:
 - on the breaking surface one observe an area with fatigue breakage (gradual) representing about 90 % of the total breaking surface;

- rhumb lines trace of fatigue crack (concave arcs against breakage centre showed that upon the axle was applied cyclical stress by stretching – compression until complete breakage);

- the axle breakage is a fatigue fracture;
- one could not identify the tendency to this fatigue fracture because the exterior areas of the two fracture surfaces were distorsioned due to the repeated blows of the open cracks surfaces until complete breakage;
- because the results of these tests, examinations and determinations were within the limits imposed by reference documents, one could not identify any favoured factors of these breakage;
- the breakage occurred as a result of exceeding the fatigue limit of the material from which the axle was made, which favoured a large number of stretching – compression cycles that were applied on this axle along its length of operation, from the date the pair of wheels were mounted at the locomotive EA 040-139-2 - 12.01.2006 the axle covered a distance of 352.501 km.

The direct cause of the incident occurrence exceeding the material fatigue limit from which the axle no.41751 was manufactured.

The Romanian Railway Safety Authority together with the railway transport operators will analyse the opportunity that, at the pair of wheels of the type involved in this incident, after a certain operation period, to be increased the frequency of the ultrasonic inspections.
