INVESTIGATING REPORT

On the railway accident occurred on the 21st of September 2009, on the track section Craiova – Caracal, on the open line between the railway stations Banu Maracine and Malu Mare, at the km 201+149, consisting in the derailment of the locomotive and the first seven wagons of the passenger train no. 1692.

Final edition
The 24th of February 2010

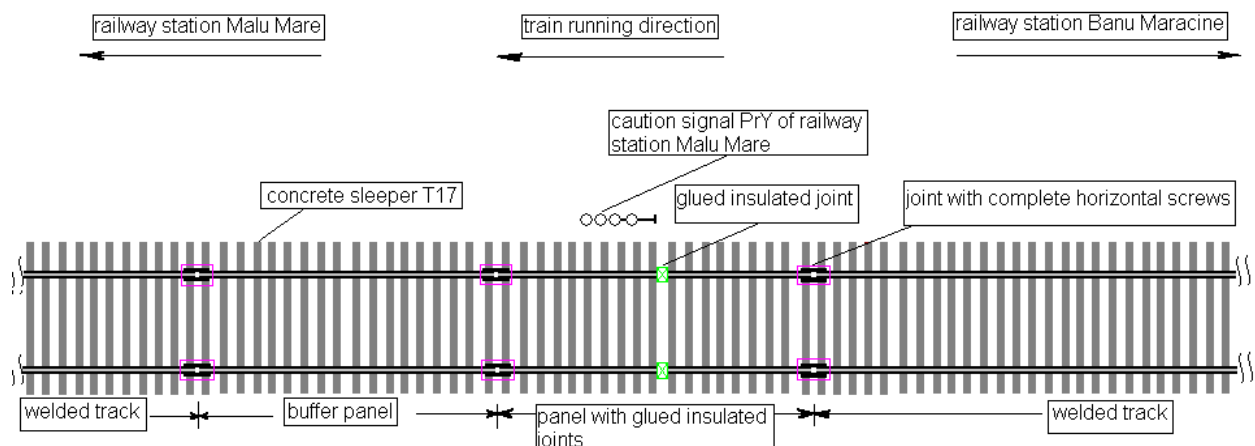
drawing no.1

drawing of the achievement of the breack in the welded track

Note: Use in operation of a single buffer panel for protection on a non-welded track with rail type 65 next to a panel with glued insulated joints instead 2 buffer panels for protection , is not in accordance with the provisions of annex 3, point 4, letter a) from the Instruction for the building, maintenance and surveillance of the non-welded track no. 341/1980 (re-published 1997), but it does not influence the normal functioning of the non-welded joints, the role of those two panels being to reduce the streching efforts in the insulation of the glued insulated joint at lower temperatures than the fastening temperatures of the non-welded joints.

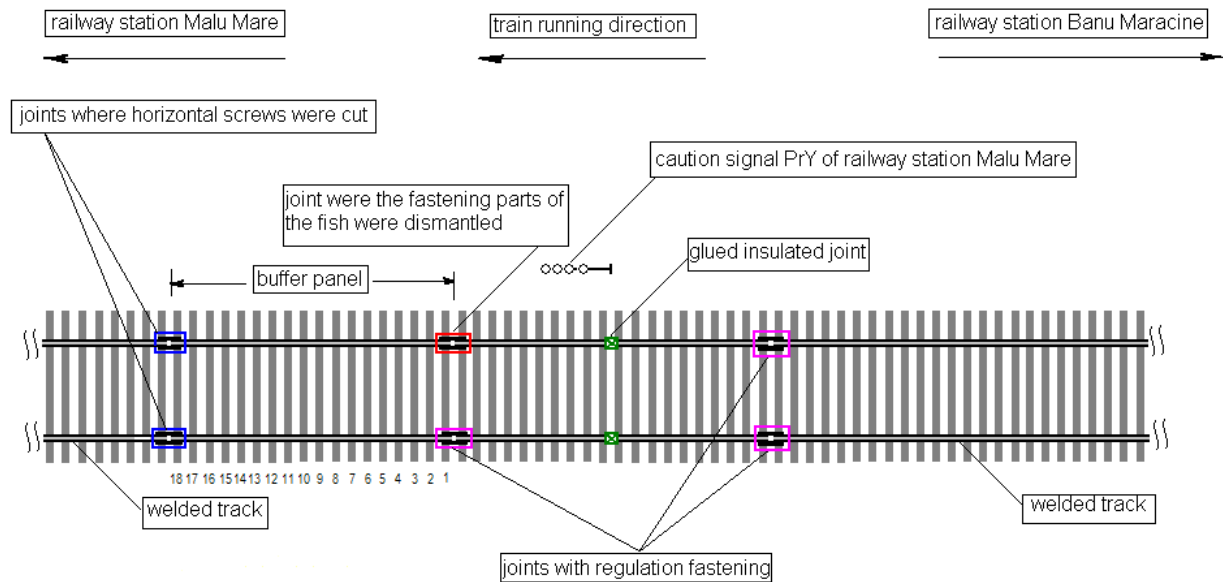
drawing no. 2

the technical situation of the joint after the accident

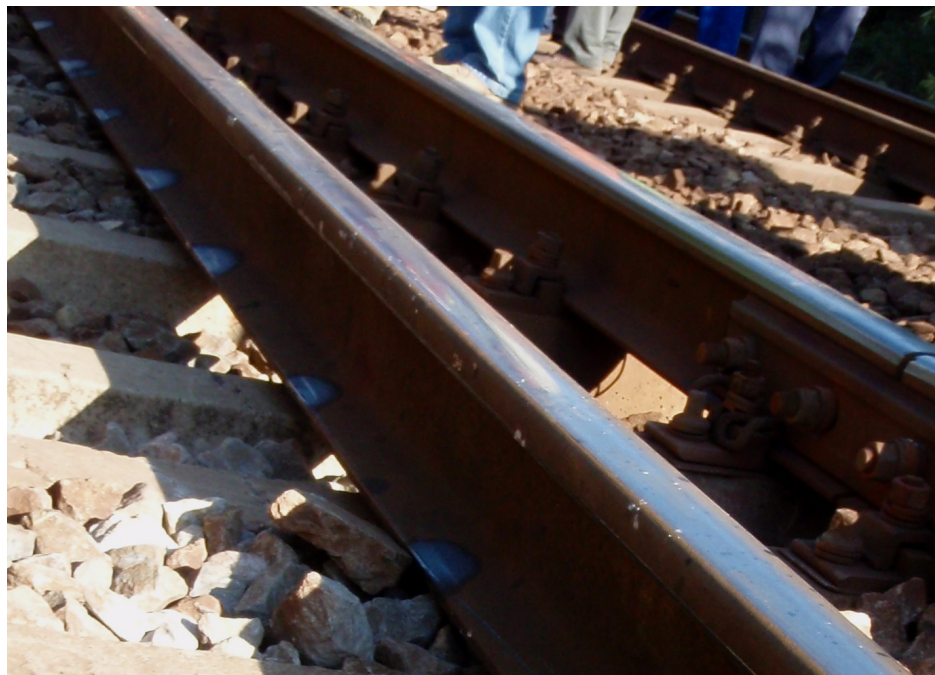
picture 2

- at the metallic for the fastening of the parts of the base of rail on the metallic plates, it presented recent spots of lubrication material;

traces of lubrication material on the base of the rail

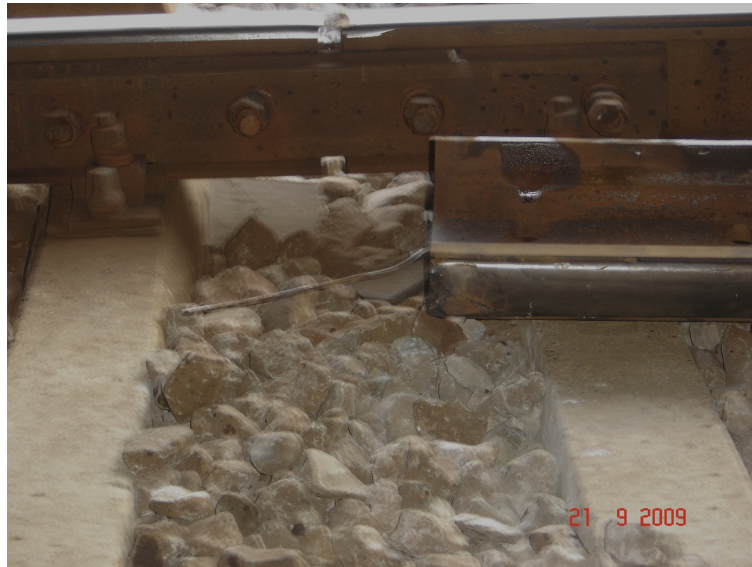
- this type of rail was under the 7th derailed wagon, on the concrete sleepers being discovered overturned between the lines with the base of the rail orientated to the left rail (in the direction of the train running) of the line II and it was about in the same position as in operation;

position of the overturned rail picture 3

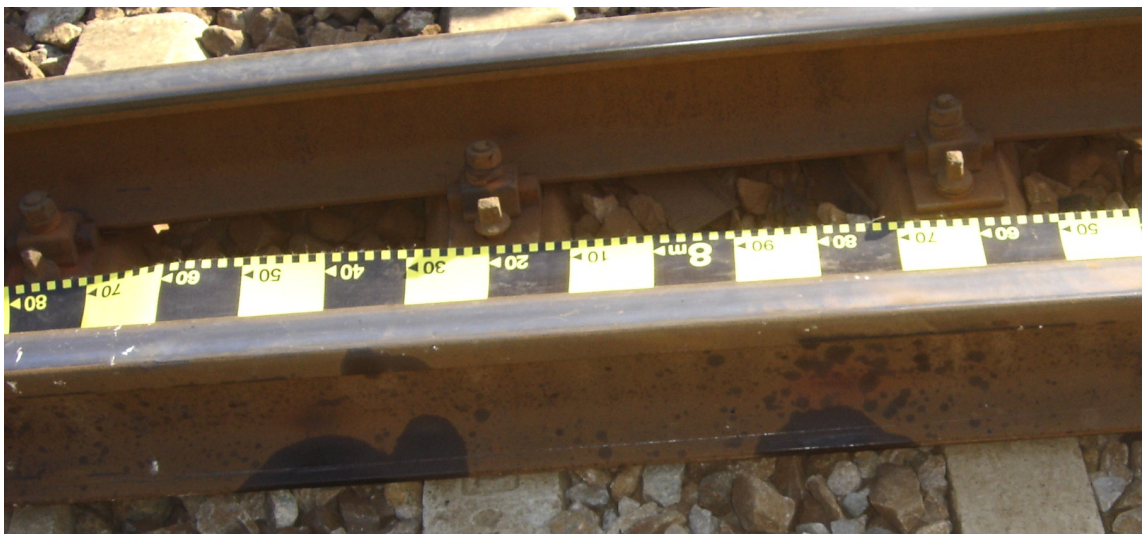
-on the right lateral surface of this rail, starting from about 2 m from the detached joint, on the upper surface of the base of the rail and on the connection area of the base of the rail with the web of the rail there were found out continuous traces generated by the derailed wheels of the rolling stock;

traces left by the rolling stock on the base of rail picture 4

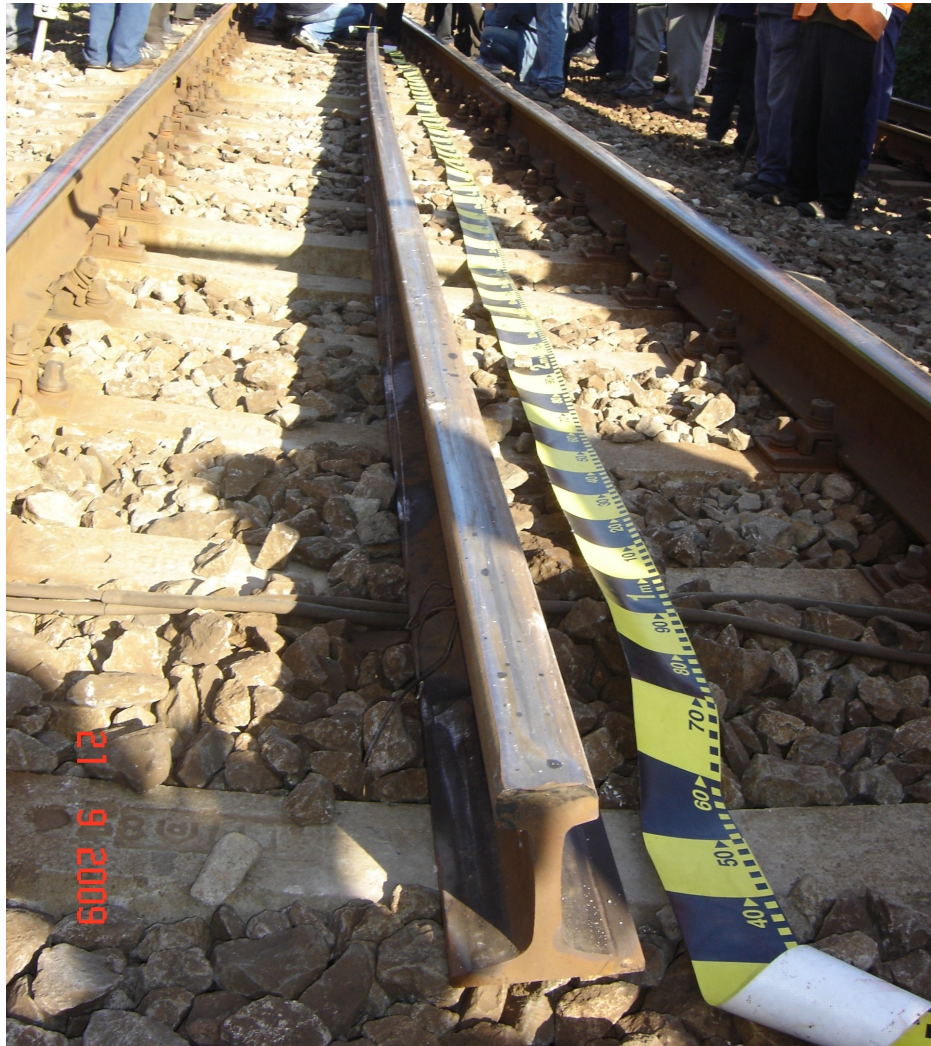
picture 5

-the rail with the detached fastenings and found out between the lines is distorted (curved) on the track flat on the first 3 – 4 m from the end of the detached joint;

*distorted rail following the push lateral forces
generate by the derailed rolling stock*

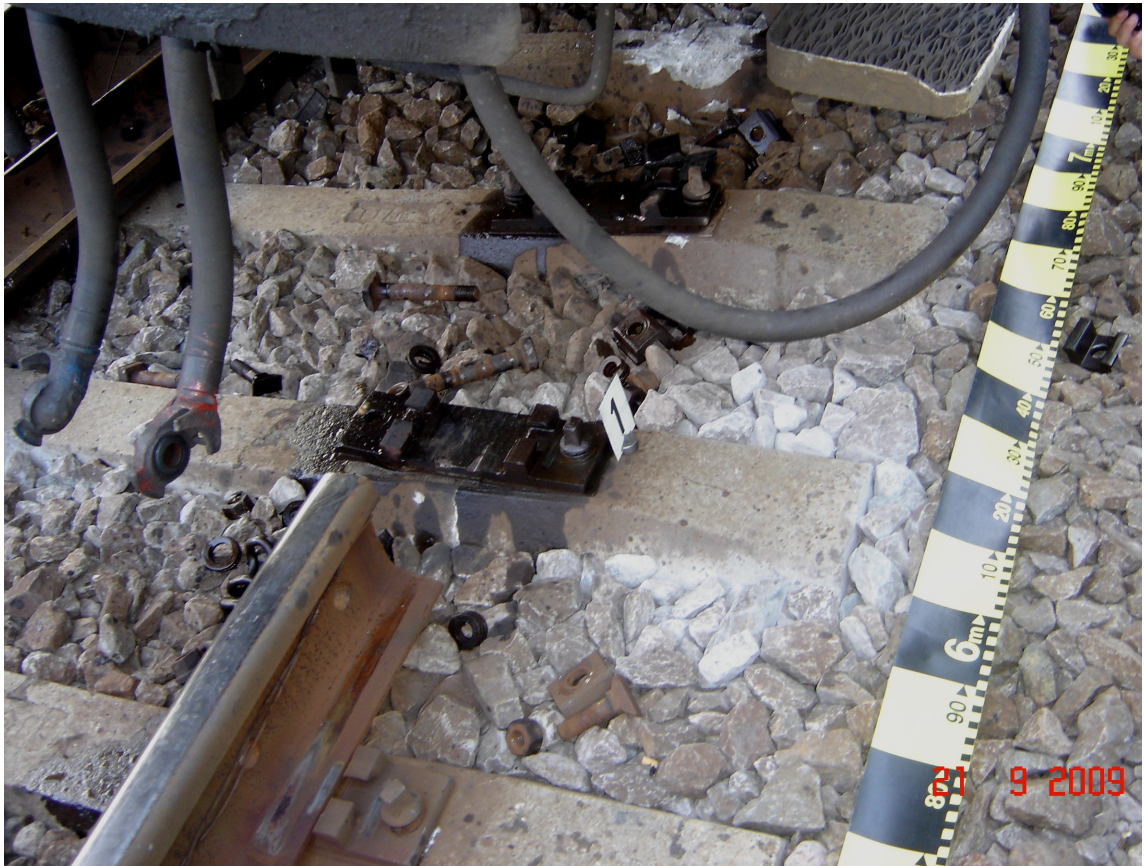
picture 6

-the joint that connects the rail section and the glued insulated joint was detached, the plane crews, the spring rings and the nuts being found out between the sleepers and the broken stone track bed. The left fish-plate (at the centre of the track) of this joint was found out inside the track;

dismantled joint

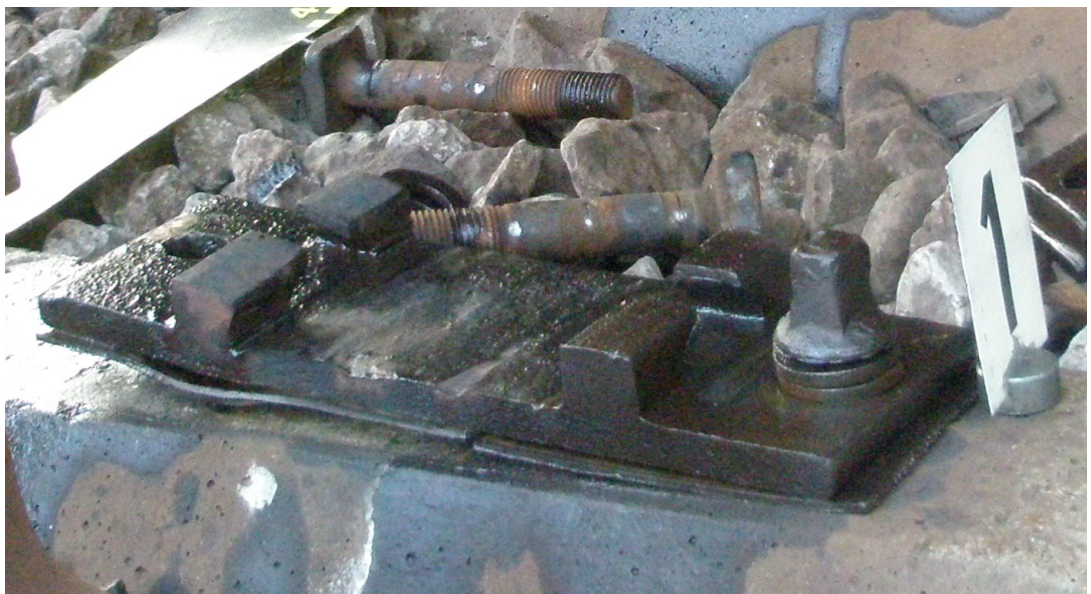
picture 7

-the metallic plate from the first sleeper of the detached joint had traces made by the stresses induced by the rail movement and the wheels running as well as by its shoulders distorted by pressing, the most probably because of the movement of the base of the rail to inside of the track, hypothesis supported by the traces on the base of the rail;

metallic plate on the right side in the direction of the train running

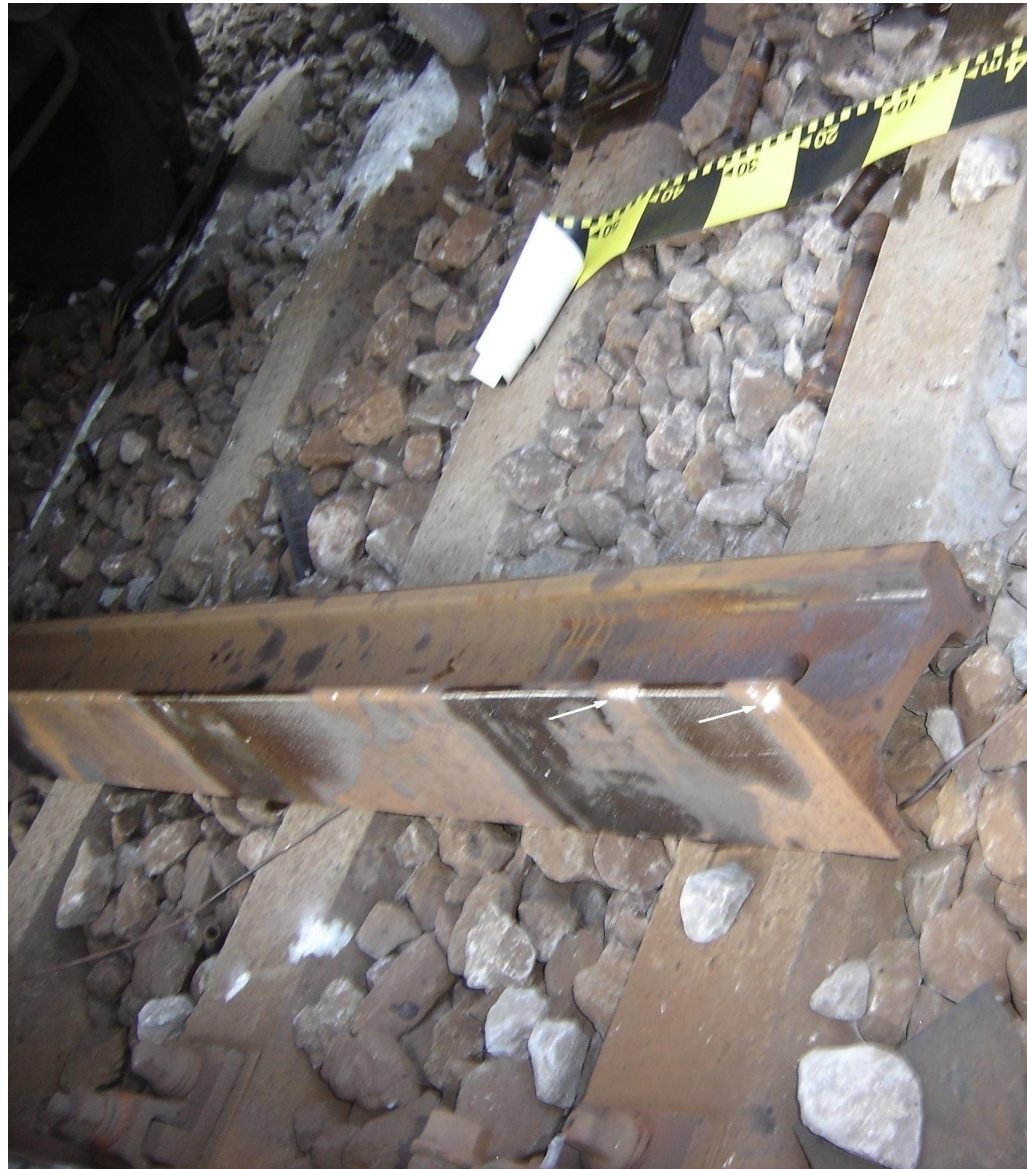
picture 8

traces on the base of the rail

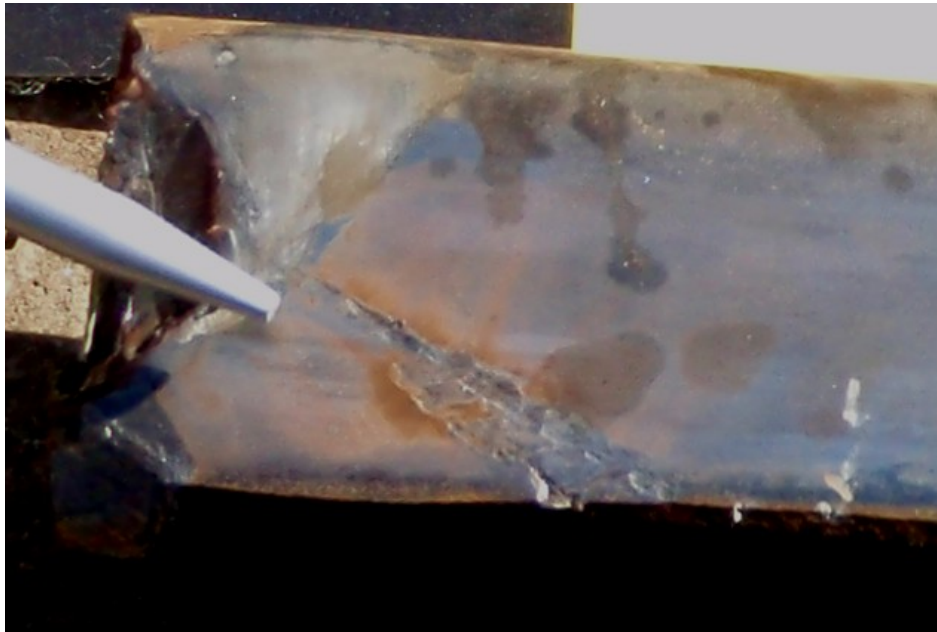
- the end of the rail from the glued insulated joint had a trace of frontal impact, having the metallic material detached from the rail head and on the running surface of the rail head, starting from the centre of the rail head to the right lateral face there was a trace specific to the running of the flange of wheel, followed by the derailment;

metallic material detached from the rail head and the trace of running of the wheel flange picture 9

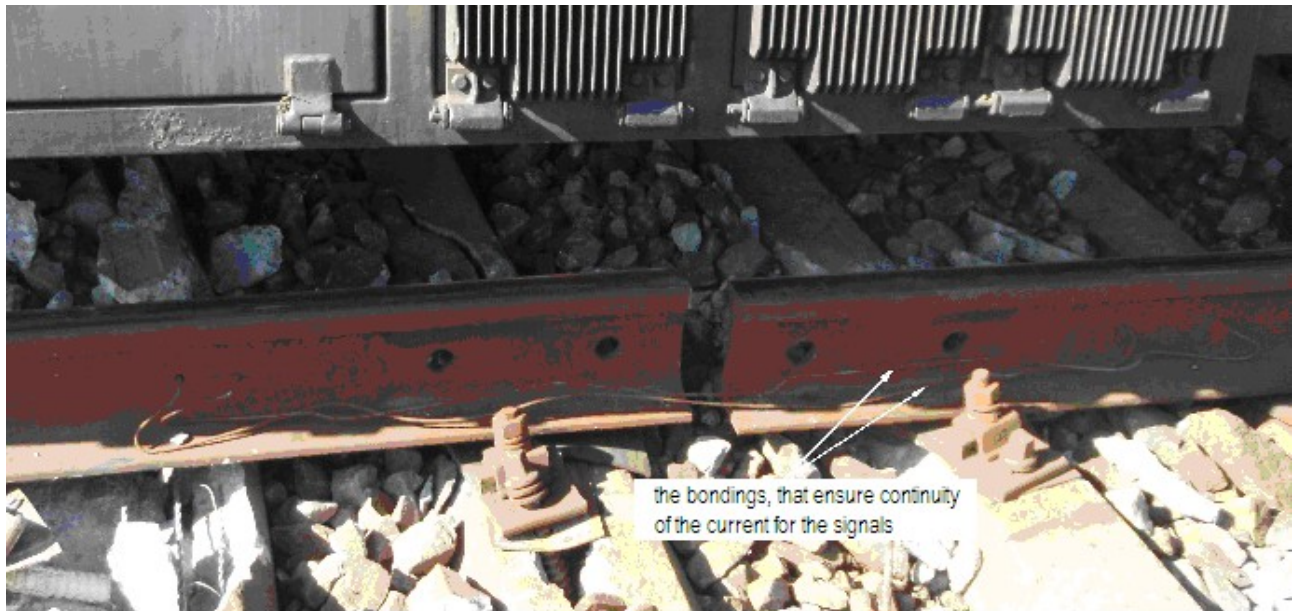
- ensemble „joint” between the glued insulated joint and the rail from the buffer panel was fitted according the instruction, with all the components active. This joint was not affected by the derailment;
- ensemble „joint” between the rail of the buffer panel and the non-welded track section, had the horizontal screws bent and broken, and those two fish plates were thrown on the track bed, following their impacts with the derailed railway vehicles.
- at both joints the bondings, that ensure continuity of the current for the signals, were not cut.

joint from the left side of the running direction between the buffer panel and the non-welded track picture 10

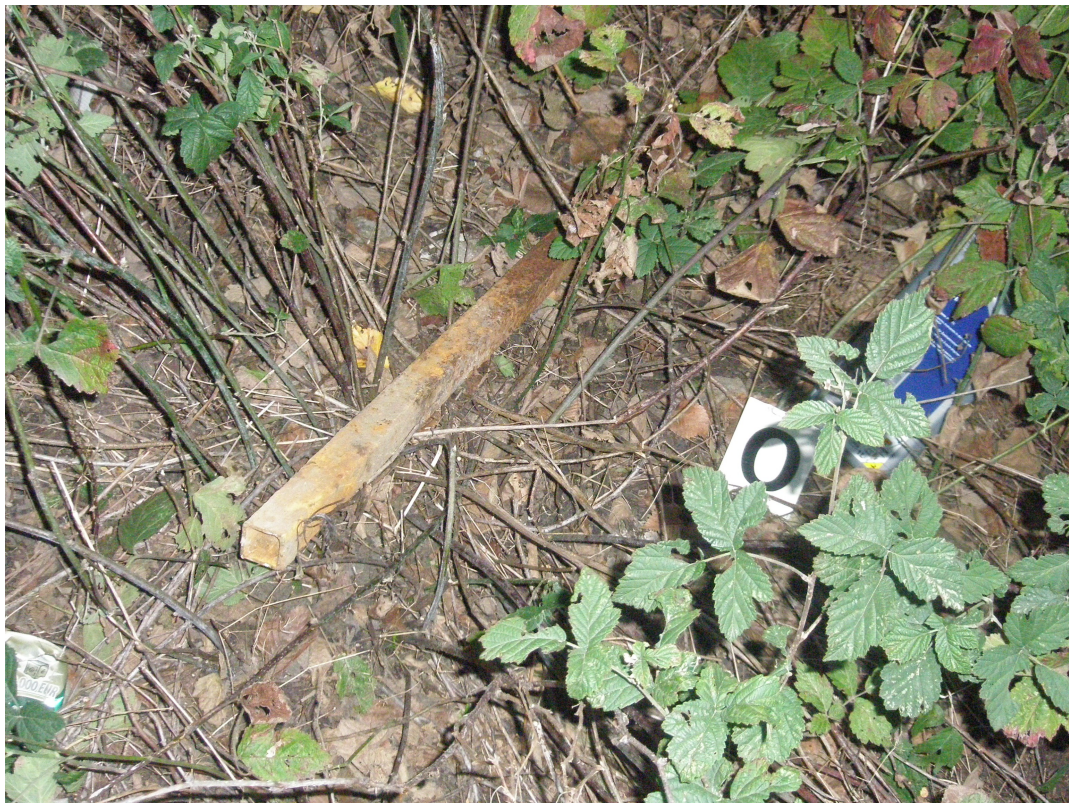
- on the right side of the line II, in the running direction, at about 6 m from the caution signal PrY of the railway station Malu Mare and at about 2,5 m from the clearance was found a plastic box of 1l with label PETROM and inscription „Motor Oil Bike 2T” with liquid (about 250 ml). Also, next to the box, at about 20 cm, was found a metallic tube of 1 m of square section and traces of impact to outside;

the metallic tub of square section and the box with the label „Motor oil bike2T” picture 11

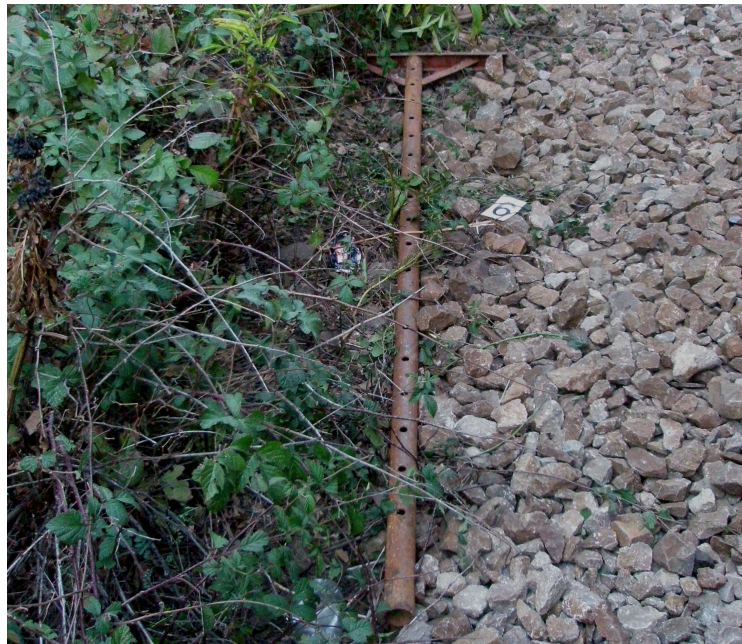
- parallel with the line, at about 1,6 m and at 8 m from the signal PrY, was found a metallic tube type construction scaffold of about 2 m.

metallic tube type construction scaffold picture 12

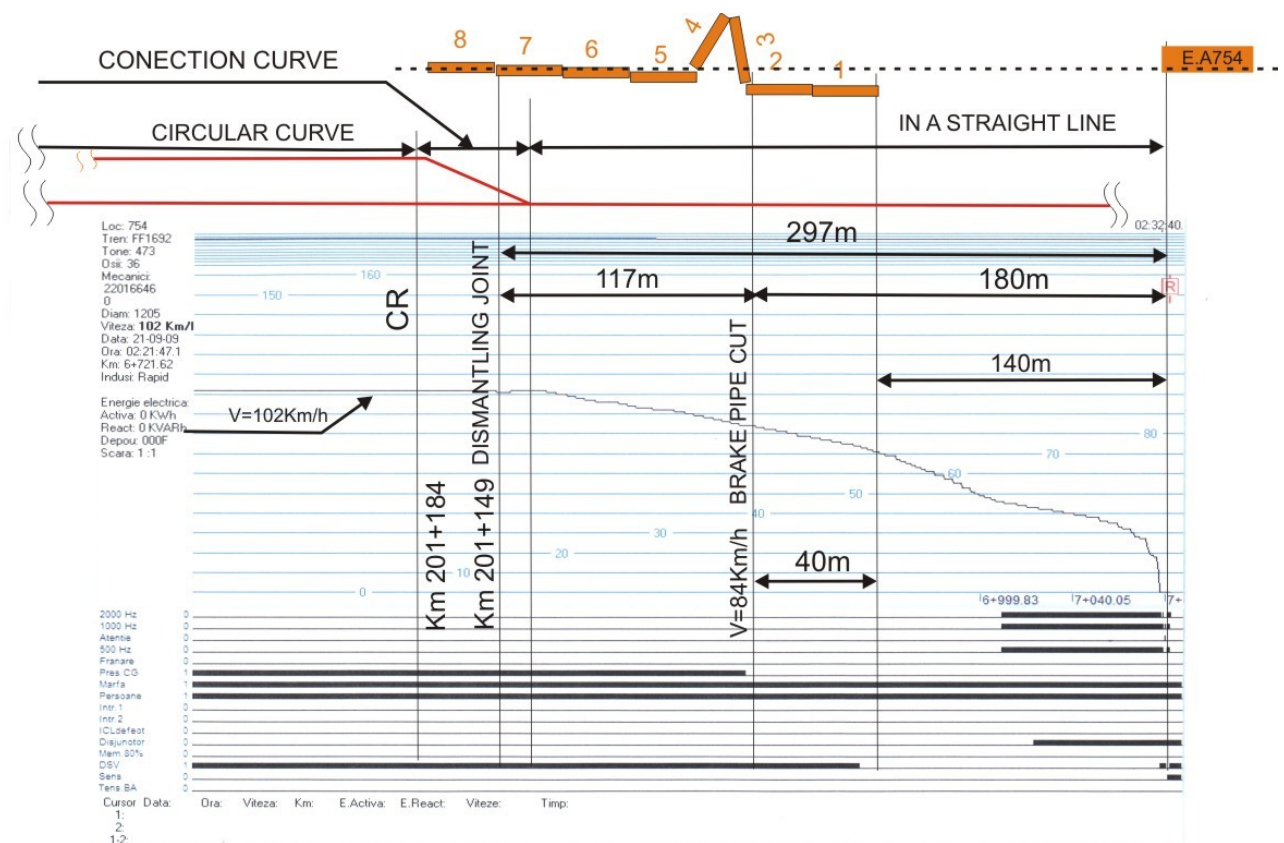
picture 13

- the train speed decreased from 102 km/h to 84 km/h on 117 m;
- at 2:21':53'' hour the continuity of the air general pipe cut at 84 km/h speed;
- at 2:21':56'' hour, after 50 m started to function the equipment DSV of the locomotive – broken of the locomotive inductor, the train speed decreasing at 74 km/h;
- at 2:22':01'' hour the equipment IVMS recorded the disconnection of the automatic circuit breaker and the train speed decreased at 43 km/h on 14 m – catenary breaking;
- at 2:22':09'' hour the train stopped after 54 m;
- the distance between the breaking of the train and the interruption of the general air pipe up to the stop of the derailed locomotive is 180 m.

the diagram of the records of the equipment IVMS on which overlapped the position of the locomotive EA 754 and of the coaches after the derailment

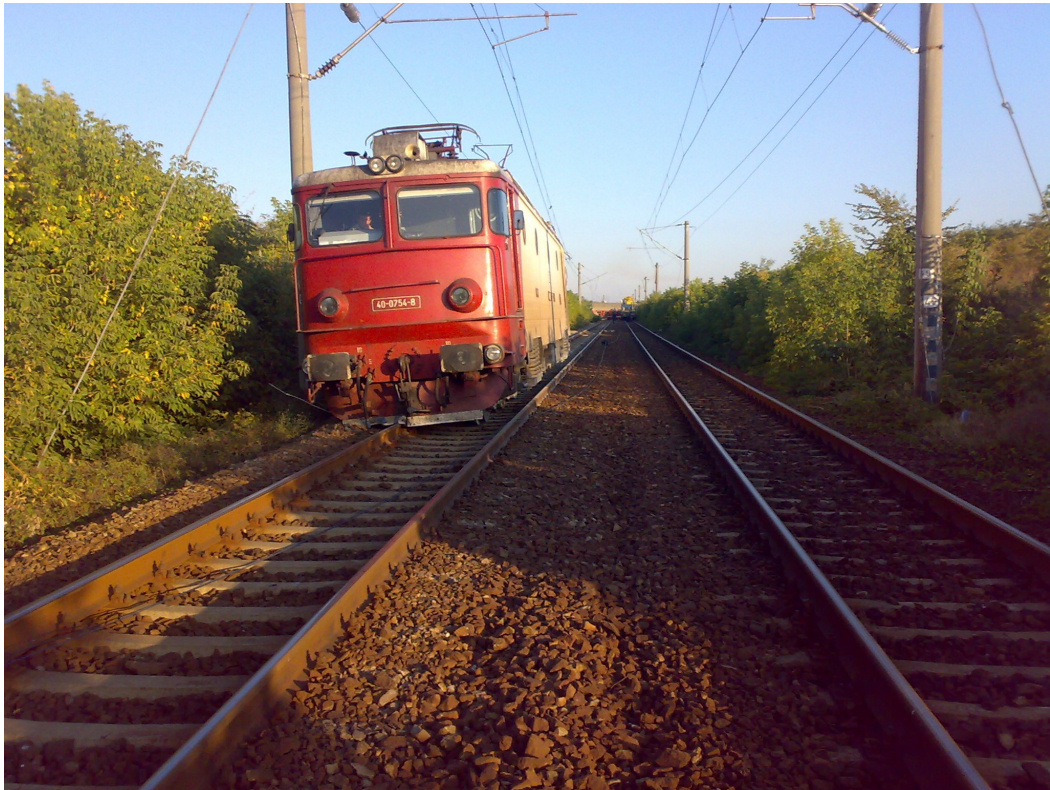
picture 14

- the locomotive EA 40-0754-8 was detached from the train and with all the axle derailed, with the left wheels (in the running direction) between the rails of the line and was at 140 m from the first coach;

derailed locomotive

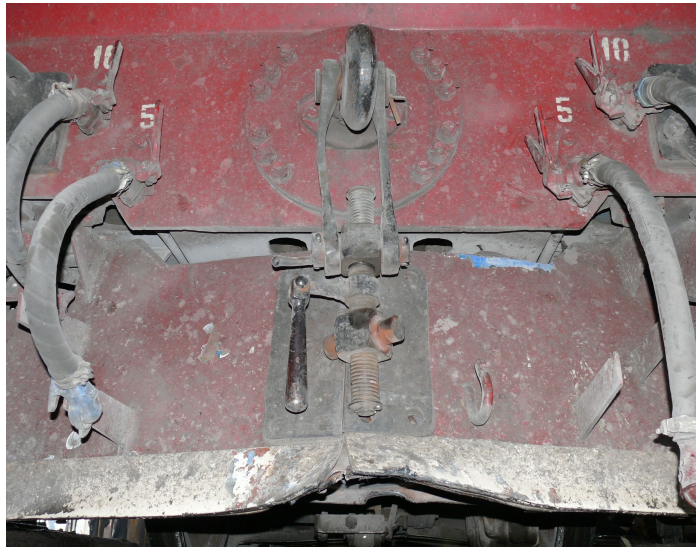
- the traction coupler had the binding chain broken;
- the left fish plate of the traction coupler distorted because of the displacement to the right of the running direction of the locomotive trajectory against the coaches trajectory;
- the animal anti-impact in the middle section was vertically distorted because of the contact with the rail from the right of the track in the running direction, achieved in the running of the derailed locomotive.

animal anti-impact distorted picture 15

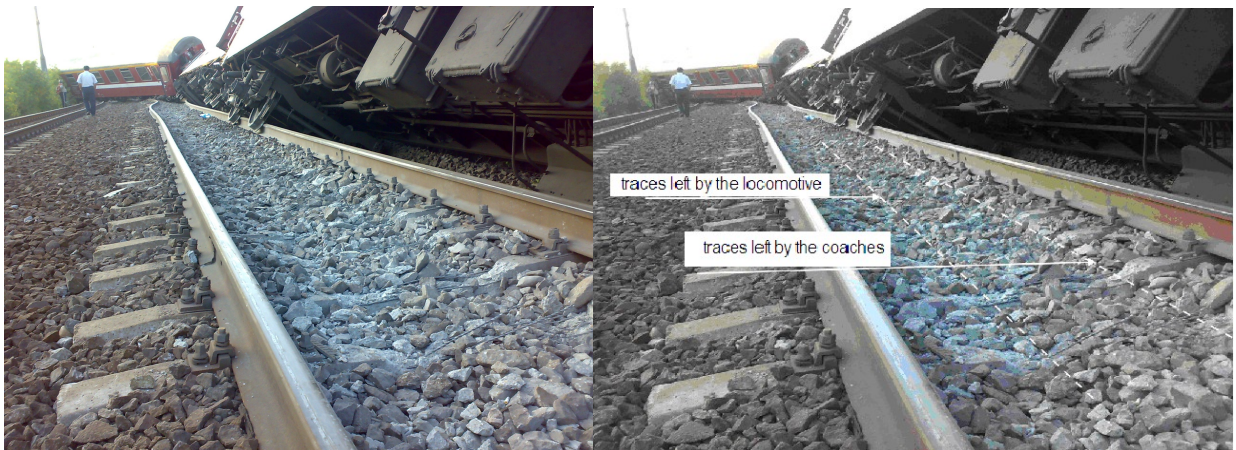
- the locomotive run with the left wheels, in the running direction, on the track centre, the traces on the sleepers being visible from the panel detached to the locomotive stopped and derailed;

traces left by the locomotive, left flange wheels of the locomotive picture 16

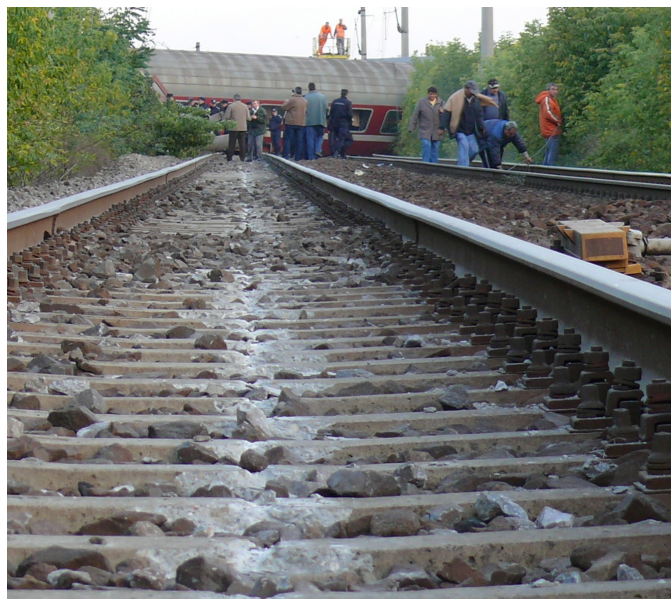
the sleeper damaged by the flange picture 17

of the left weels on the left side of the locomotive

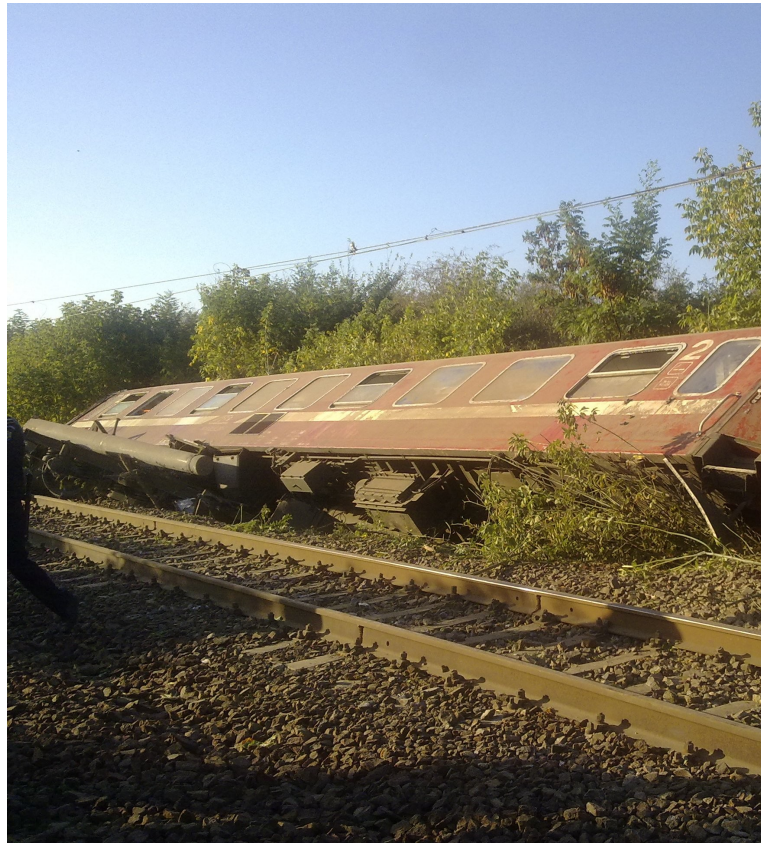
picture 18

- the coach no. 50532055092-2, first of the train, derailed and reclined on right side of the running direction, its front being at 2.5 m from the rail of the right side in the running direction and its back being at 2.2 m from the rail of the right side of the running direction. The first bogie of the coach was between the coach and the line II;

first coach of the train

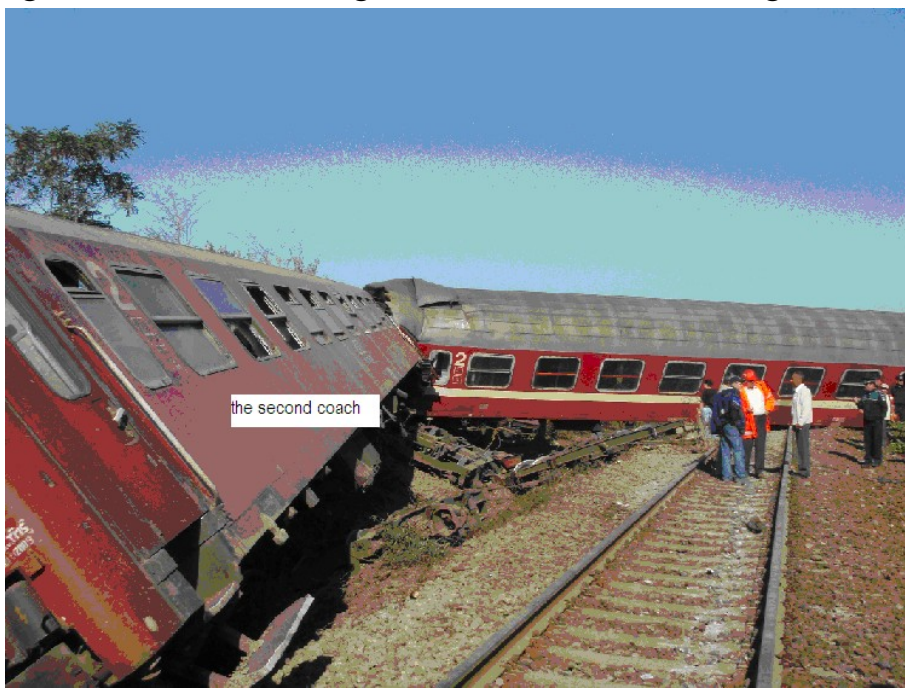
picture 19

- the coach 50532054060-0, the second of the train, derailed and overturned on the right side of the running direction, its front being at 0.7 m from the rail of the right side of the running direction and its back being at 7.9 m from the rail of the right side in the running direction. The second bogie of the second coach

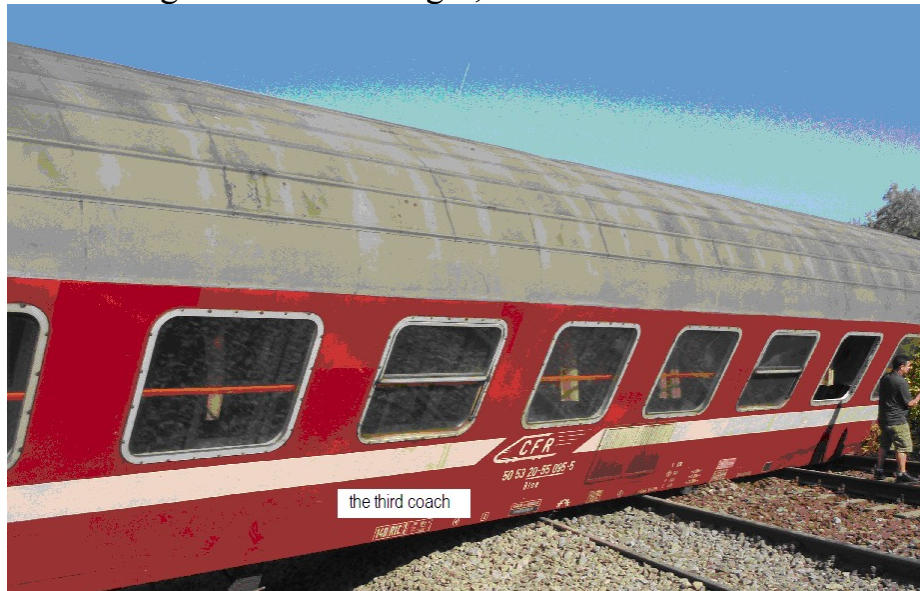
picture 20

- the coach no. 50532055095-5, the third of the derailed train, reclined to the left and placed in an angle of 60° to the right, on both lines of the track.

the third coach of the train

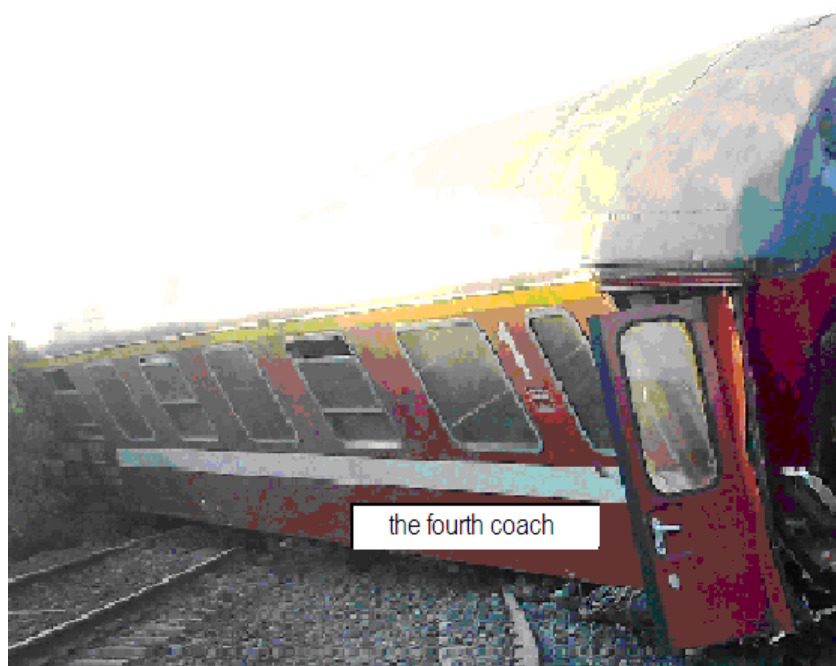
picture 21

- The coach no. 50531955009-9 the fourth of the derailed train and place in an angle of 30° to the left on those 2 lines of the track;

the fourth coach of the train

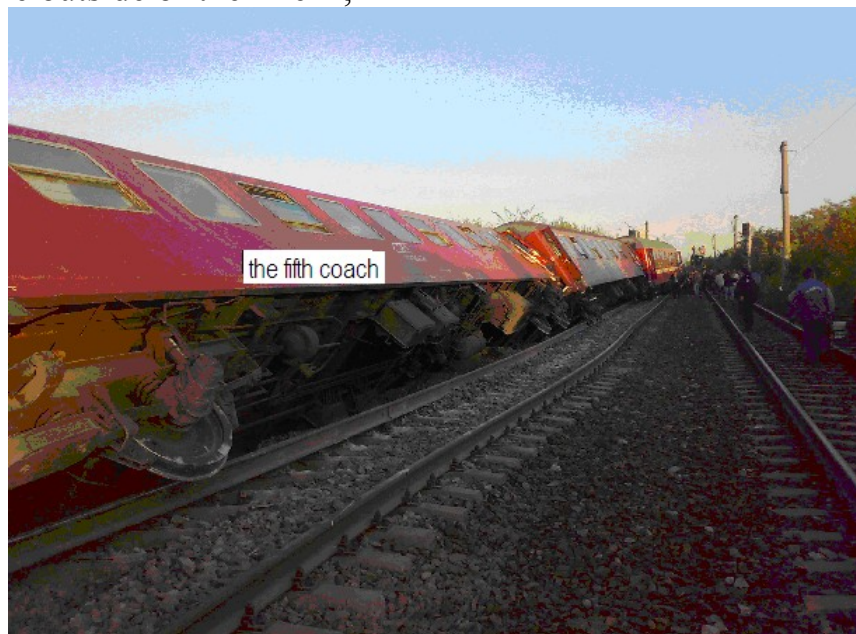
picture 22

- The coach no. 50532054033-7 the fifth of the derailed train and reclined to the right, with the right wheels on the track bed and the left wheels hung above the rail from the outside of the line II;

the fifth coach of the train

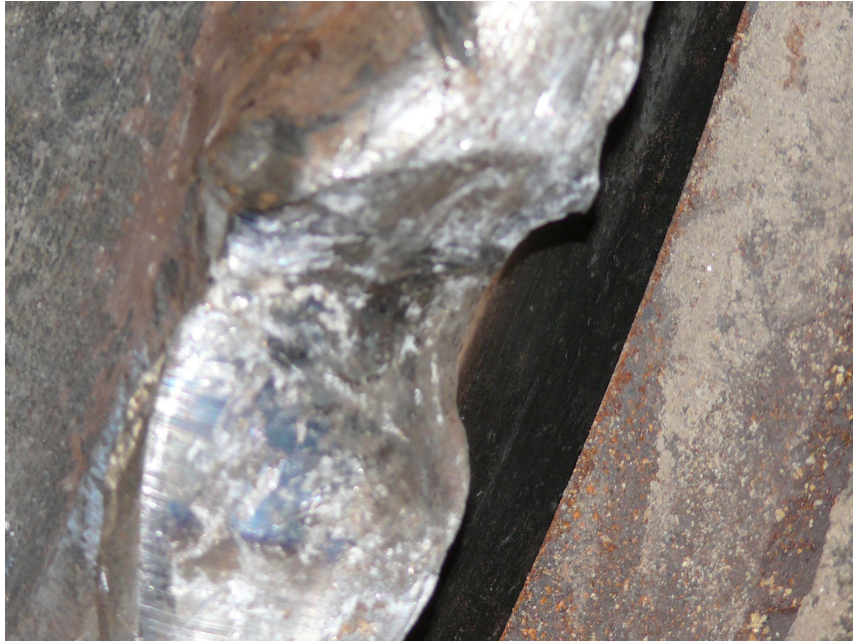
At this coach, at the wheel from the right side of the axle no. 1 of the bogie no. 1, in the running direction, was found out a distorsion of the flange of wheel following the impact of the rail section end corresponding to the buffer panel with the detached fastenings.

the fifth coach after the locomotive – distortion of the wheel flange from the right side of the axle no. 1 of the bogie no. 1 in the running direction picture 23

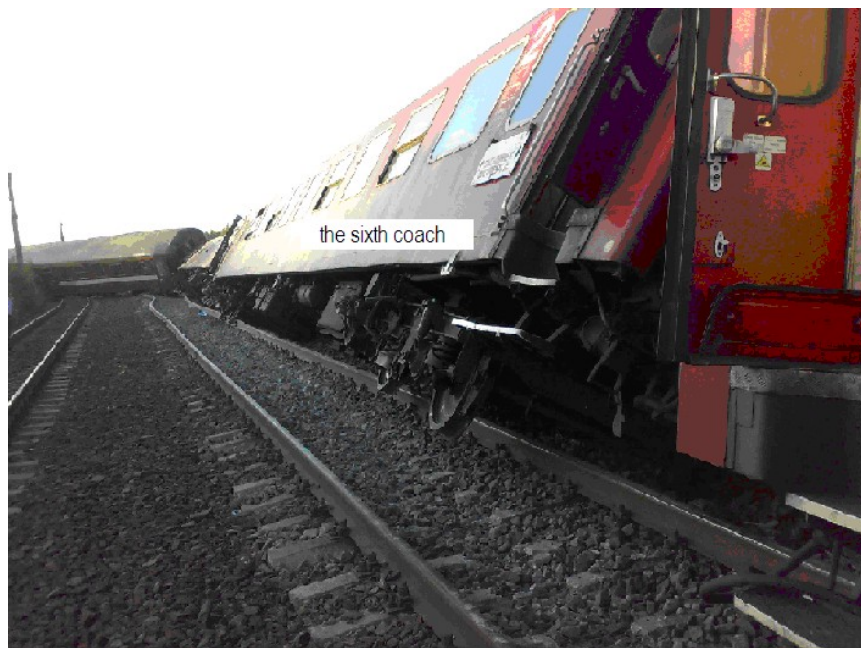
- the coach no. 50532054087-3, the sixth of the derailed train and reclined to the right, with the right wheels on the track bed and the left wheels hung above the rail from the outside of the line II;

the sixth coach of the train picture 24

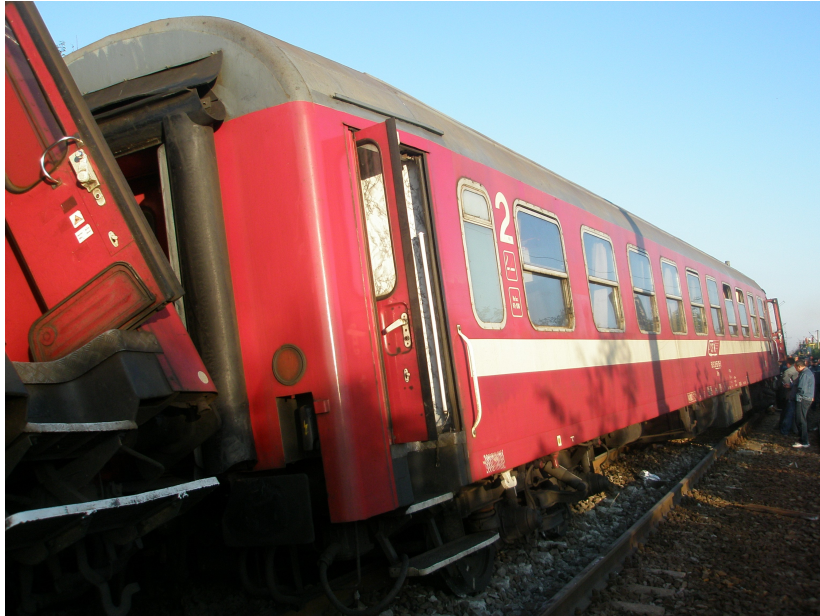
picture 25

- the coach no. 50532055105-2 the seventh of the derailed train with the first bogie at a distance of 0.83 m from the rail head and the bogie 2 next to the rail head;

the seventh coach of the train

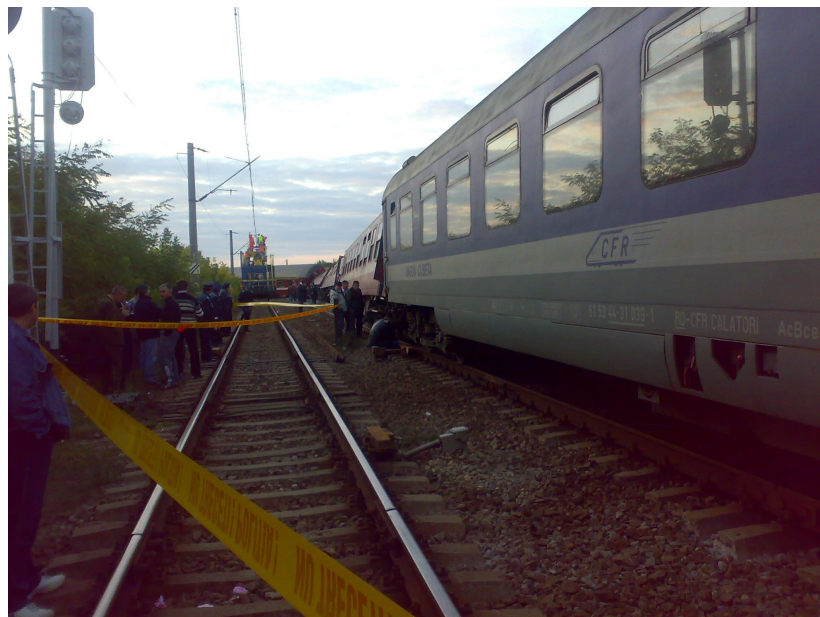
picture 26

- the wagon 61534431039-1, the eighth of the train (the last) remained on the line un-derailed;

the eighth of the train

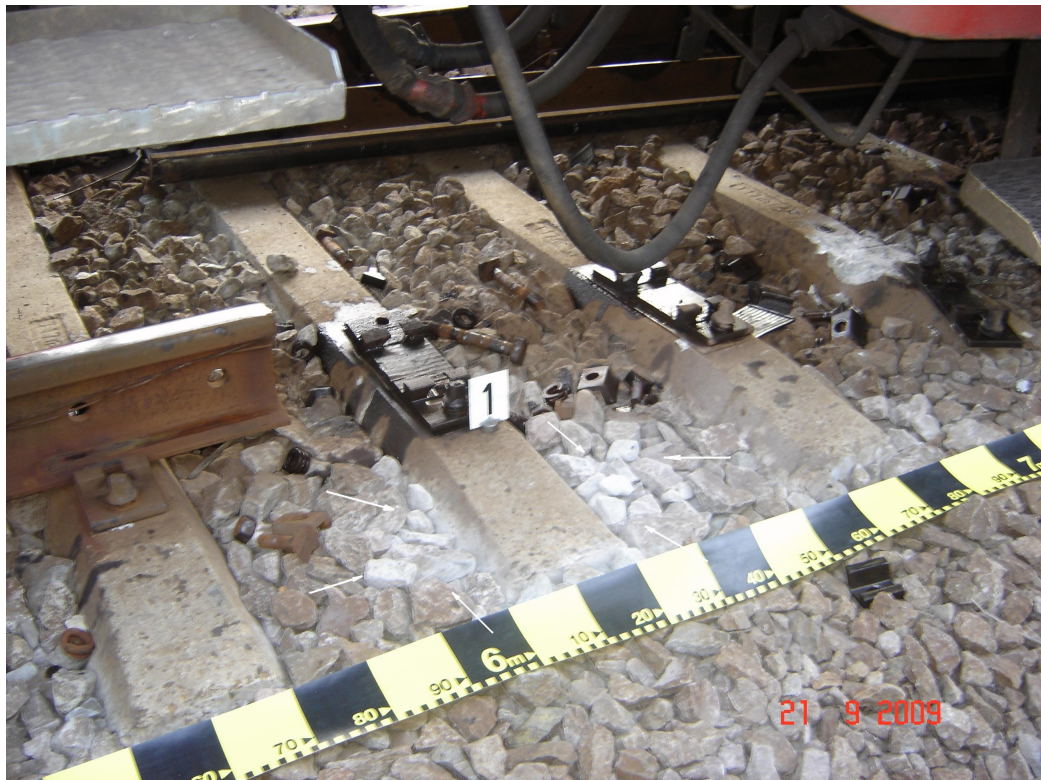
foto27

- At the des-assembled joint, the rounded broken and whitish stone existing round the right end (in the running direction) of the first sleeper from the buffer panel, indicates that it permits vertical displacements of the frame rail – sleeper. It permitted the increase of the vertical displacement of the rail end detached under the action of the vertical efforts generated by the running rolling stock.

*round whitish broken stone at right end of the first sleeper
from the buffer panel*

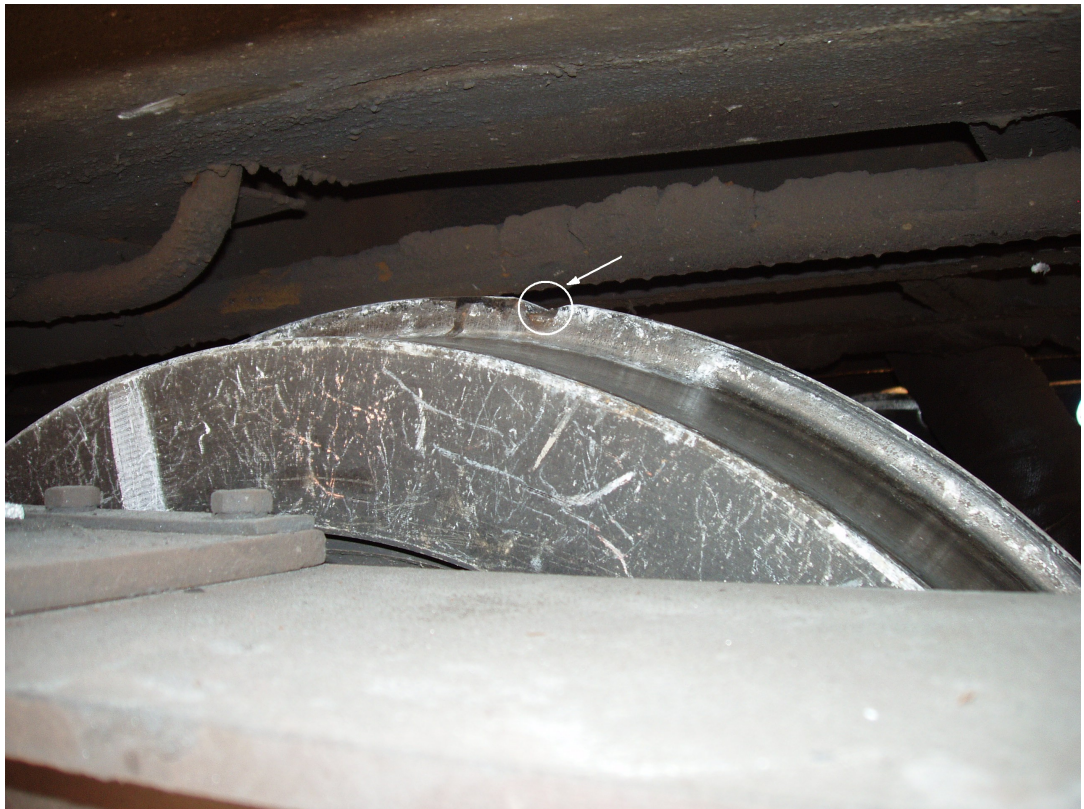
foto 28

At the derailment of the coach no. 4, the axle 1 of the bogie no. 2, in the running direction, hit the rail section from the right side (according to the impact identified on the wheel flange) at the end, generating the taking out of the rail from the metallic plate shoulder from the first sleeper of the panel.

*the fourth coche - the impact trace of the right rail by the
first axle of the second bogie*

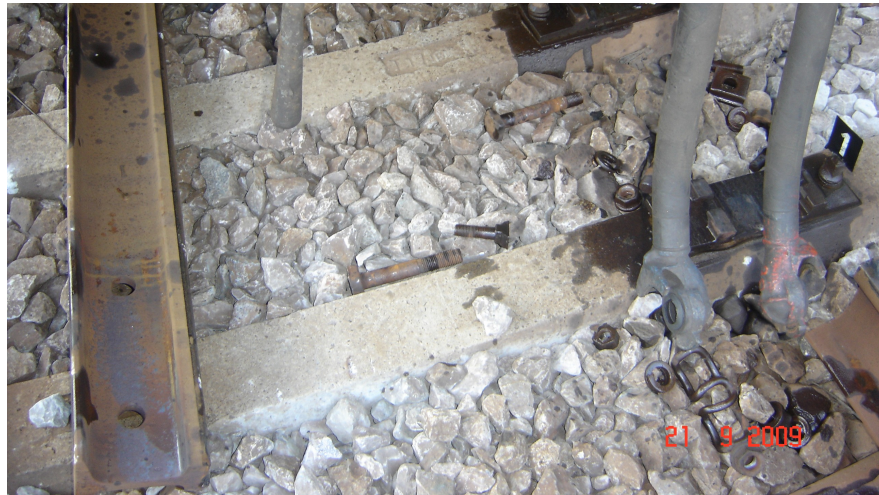
The axle no. 1 of the first bogie of the coach no. 5 from the right side of the running direction hit frontally with the wheel flange the end of the rail section taken out from the metallic plates shoulder, generating the displacement of the rail section to the track center and its overturning by turning round the longitudinal center of the rail.

rail taken out from the metallic plates shoulder foto 29
