MINISTRY OF TRANSPORTS AND INFRASTRUCTURE  
ROMANIAN RAILWAY AUTHORITY - AFER

ROMANIAN RAILWAY INVESTIGATING BODY

## INVESTIGATING REPORT

on the railway accident  
occurred on the 19<sup>th</sup> of June 2011 between the railway stations CFR Timisul de Sus - Predeal  
on the range of activity of CF Brasov Regional Branch

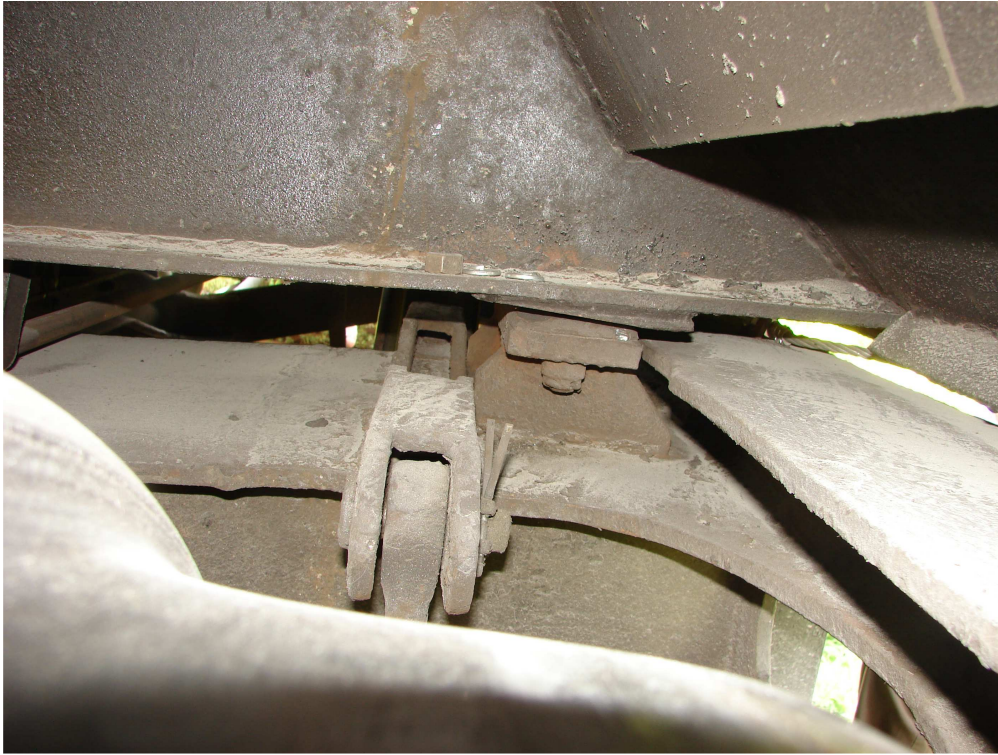
- the wagon was derailed by the leading bogie in the running direction, (the bogie with the wheels 5-6, 7-8), the wheels 5-7 on the left and the wheels 6-8 on the right in the running direction;
- at the bogie with the wheels 1-2, 3-4 (the non-derailed bogie, the 2<sup>nd</sup> in the running direction) was missing the side bearer block on the left in the running direction;
- at the same bogie, on the frame of bogie near the support of the bearer block were found a nut (metric 16) in the back side and in the front side a nut and two washers grower disposed one near the other according to the photo no. 1.

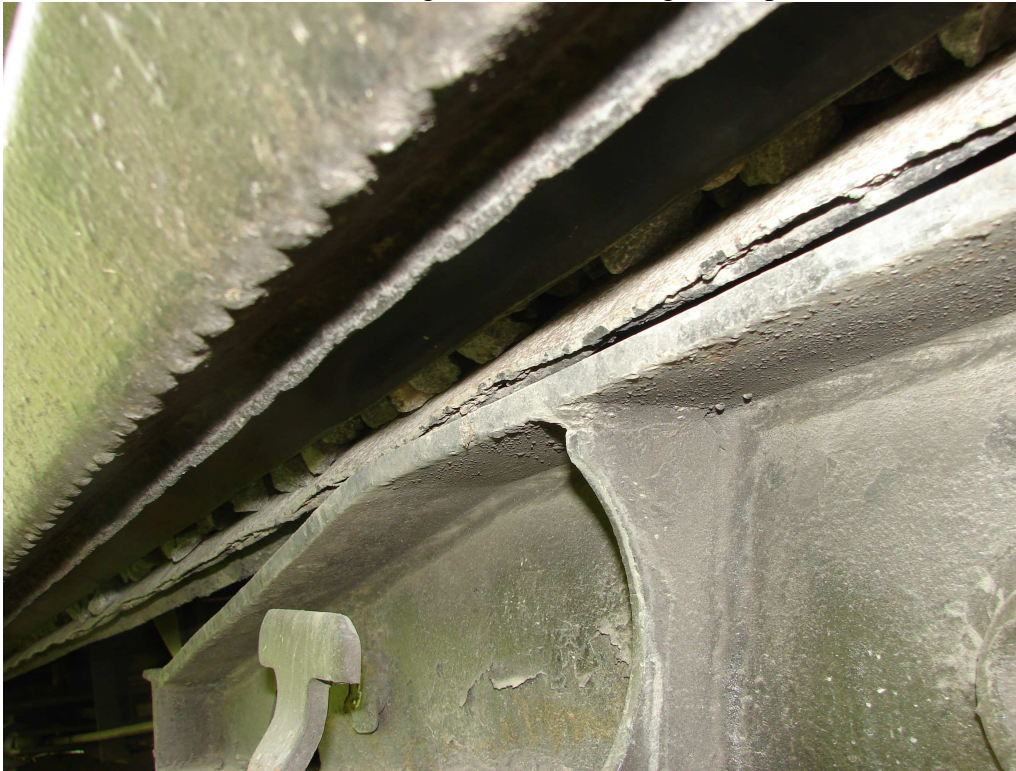
- at the non-derailed bogie, on the left in the running direction, the wagon box (swing door frame) was in contact with the bogie frame according to the photo no. 2

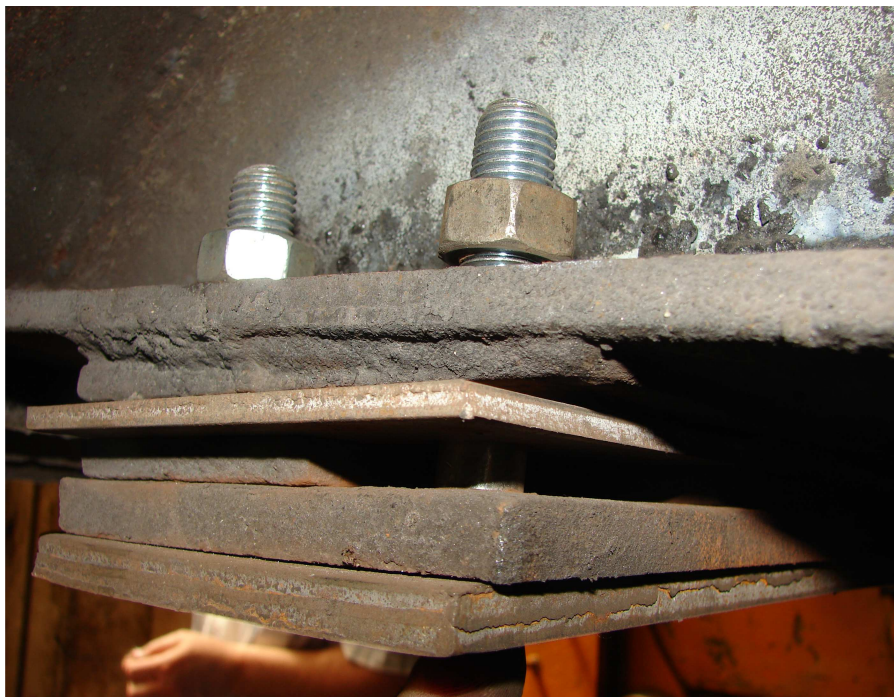
- the existing centre pivot socket liners with signs of lubrication and cracked;
- at the top the side bearer block , on the side with the wheels 5-7, two weakened screws at an end of the friction plates pack and an insuring screw of the same plate, in the opposite end, loosened, according to photo no. 3 and no. 4;

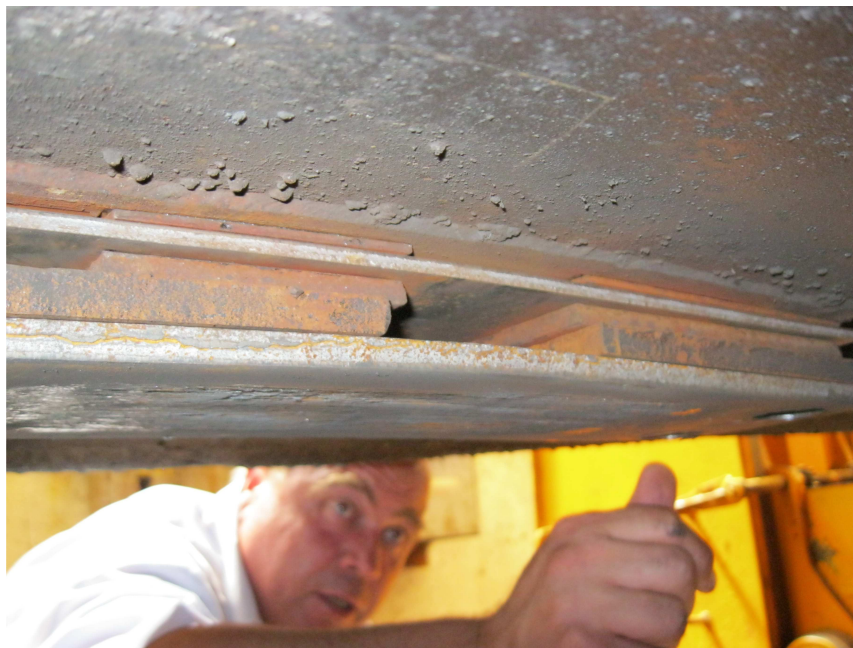
photo no. 5

- the pack of steel filler plates at the side bearer blocks formed of several pieces that did not cover the entire setting area;

- the steel filler plate at the side bearer blocks prepared of several pieces, which was not covering the entire settlement area, according to the photo no. 5;
