ROMANIAN RAILWAY INVESTIGATING BODY

INVESTIGATING REPORT

on the railway accident happened
on 02.10.2011, in the railway station Valea Albă

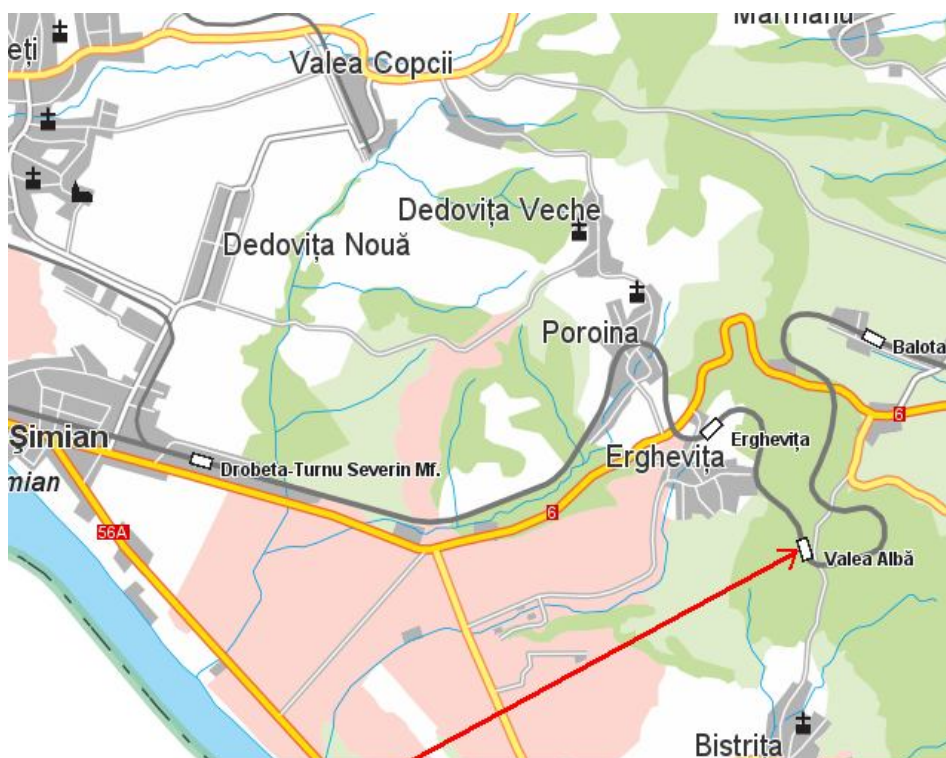
Locul producerii accidentului

The accident site is located in the Branch of the Railway County Craiova "Regional Center of Operation, Maintenance and Railway Repairs", on the running section Strehaia-Drobeta Turnu Severin (electrified single line), in the railway station Valea Albă, at km 349+060.

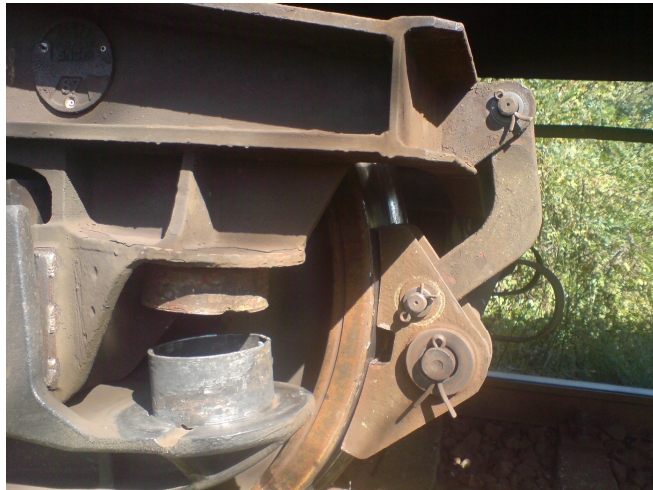
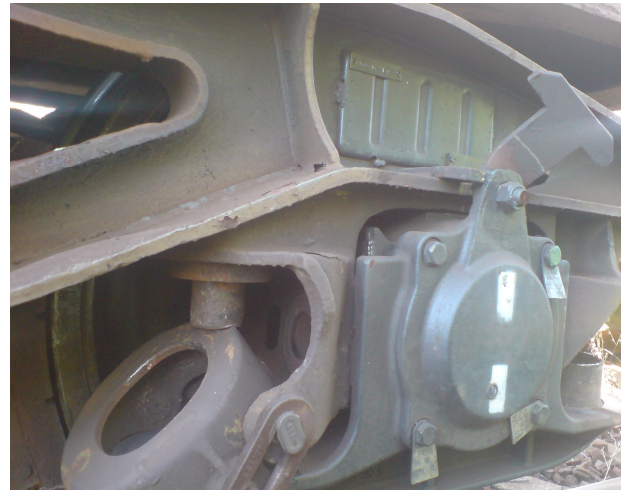
- the suspension spiral springs from the axle box 1 and 3 were missing;
- the safety limiter (T parts) from the axle-bearings of wheels 1 and 3 were distorted;

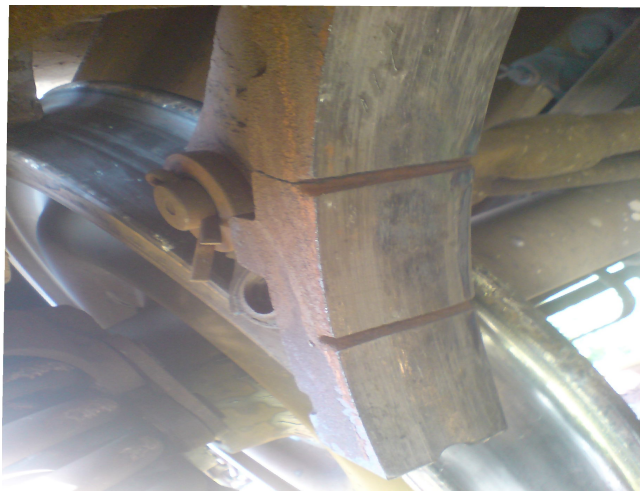
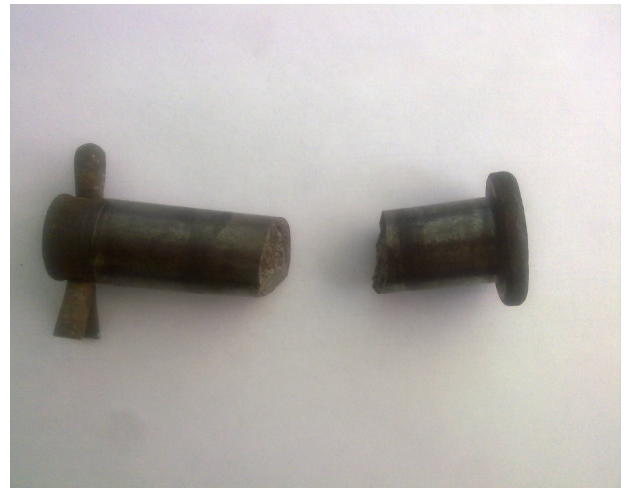
- the brake head from the inner of the wheel no.1 was turned with about 180°;
- the tie bolt between the brake hanger and brake head from the inner of the wheel no.1 was braked in two parts, and on the two brake surfaces one observe a tendency of an old shrinkage crack on about 75% of the surface.

- braking the tie bolt between the brake hanger and brake head from the inner of the wheel no.1 happened during braking at the railway station Valea Albă, as a result of a tendency of an old shrinkage crack on about 75% of the surface;

- shear off the joint bolt of brake hanger with the brake head was possible due to a tendency of an old shrinkage crack on about 75% of the surface;
- after breaking the joint bolt of brake hanger, the brake head turned around the triunghiular axis, which led the brake hanger to enter and block between the brake head and first wheel of the first axle;
