ROMANIAN RAILWAY INVESTIGATING BODY

INVESTIGATING REPORT

of the railway accident happened on 24.03.2012 in the Regional center for railway operation, maintenance and repairs Cluj, running section Sărățel – Deda, in the railway station Râpa de Jos, by the derailment of the first axle of the locomotive EA 40-0499-0 within the freight train composition no. 83599-2 belonging to SNTFM „CFR Marfă SA”

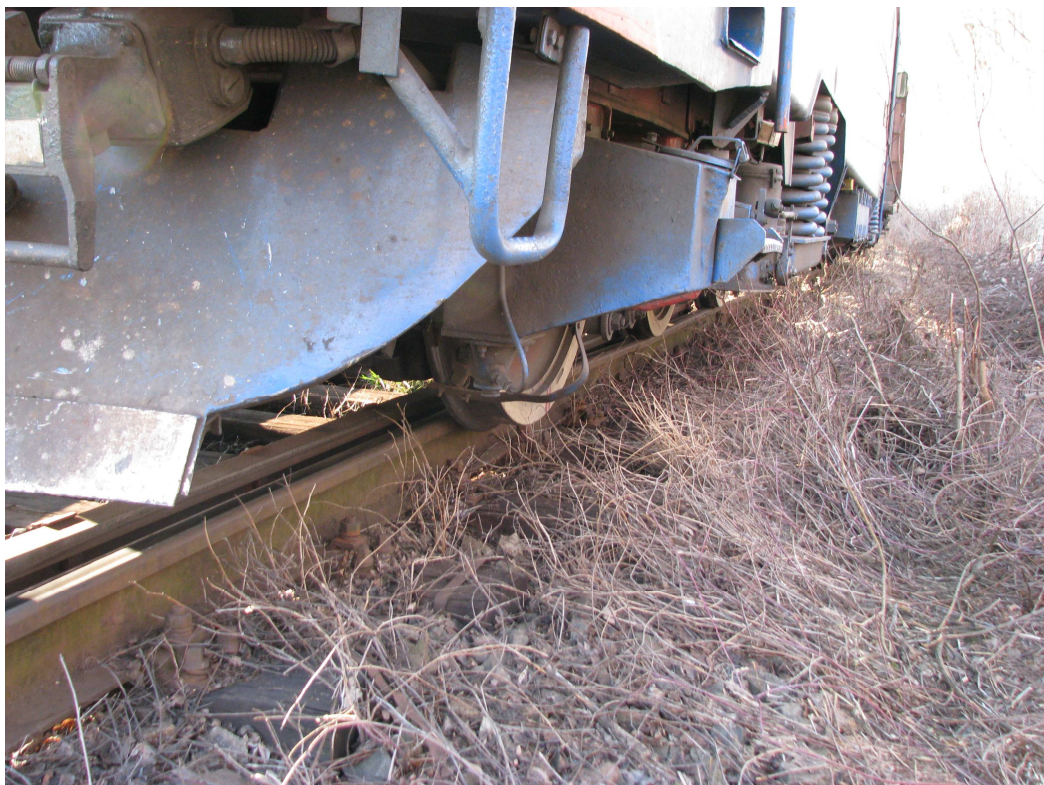
Photo 2 : *Locomotive EA 40-0499-0 - derailed*

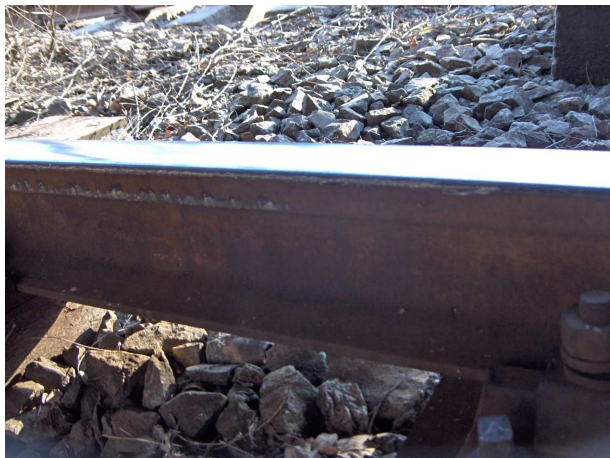
Photo 3: the place where the right wheel fell

The wheel was running in these conditions a distance of 4,8 m, place in which the track gauge returned in instructional limits, the left wheel escalated the head rail while the right wheel was back on track, running about 1,4 m, after which the left wheel fell outside the track running about 13 m until the stopping of the train.

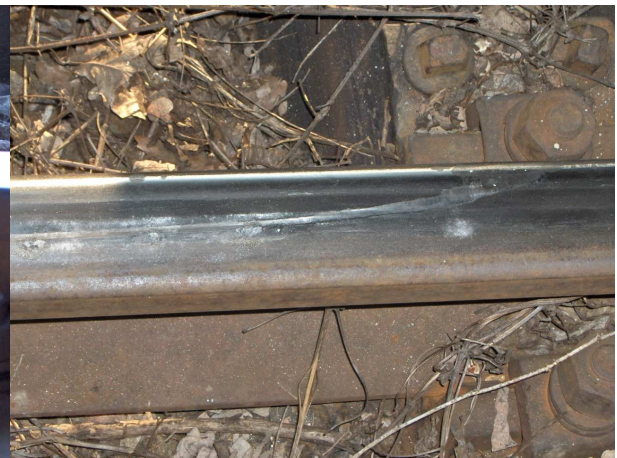
Photo 4: the place of escalating the wheel

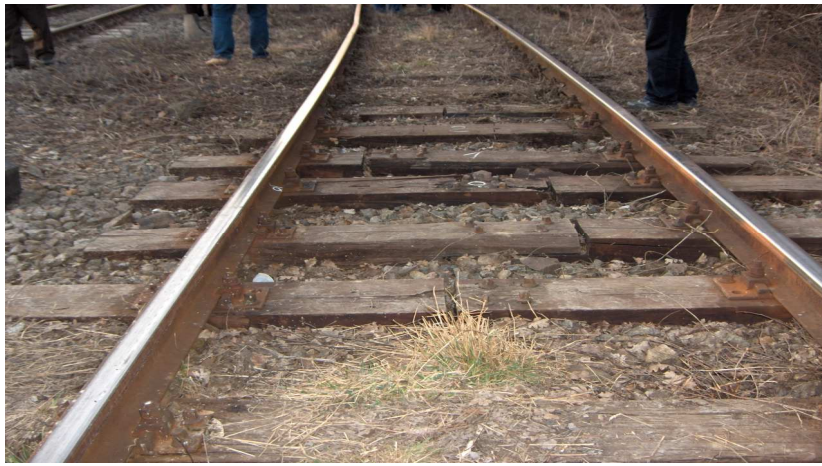
Using an improvised mounting system by which 4 normal sleepers were replaced with spliced sleepers, each sleeper was made up of two pieces.

Photo 5: line in the derailment area and joining the sleepers

On a portion of the line located 2.5 m either side of the place where the wheel fell, the position of the sleepers is tight, on track 5 joined sleepers being placed, of which 4 pieces in a row.

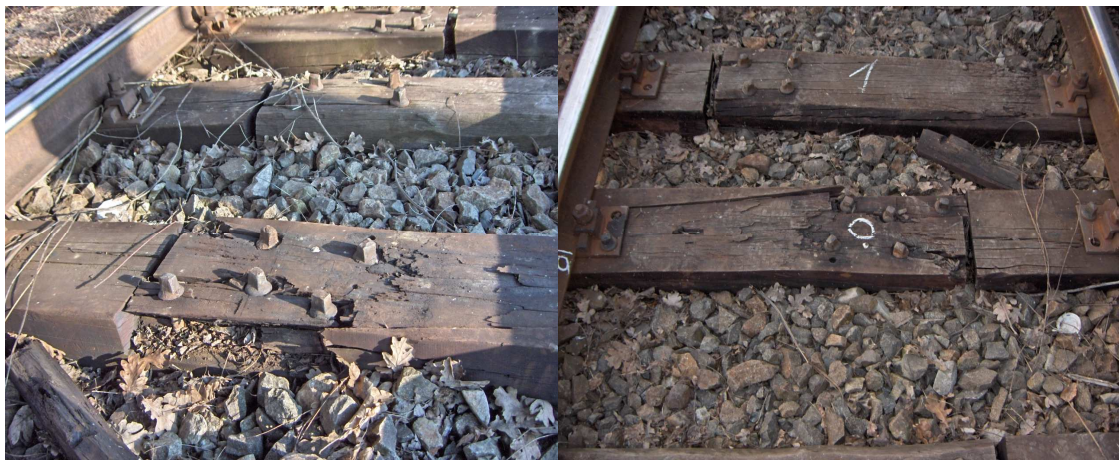
Photo 6: breaking of the joined sleeper “0”

Following the dynamic action performed by the train locomotive 83599-2 on line, the increase of gauge occurred over operational limits due to failure and breakage of spliced wooden sleepers (sleeper marked "0"). This caused the fell and the rolling wheel to the right of the first axle of the locomotive with the outside surface of the tyre in contact with the inner side of the head rail.

The direct cause of the accident consists of the inappropriate condition of the sleepers, that under the action of the locomotive transversal dynamic forces, allowed the track over-widening at values above maximum tolerances permissible in operating and fall between the rails of the right wheel of the locomotive first axle.

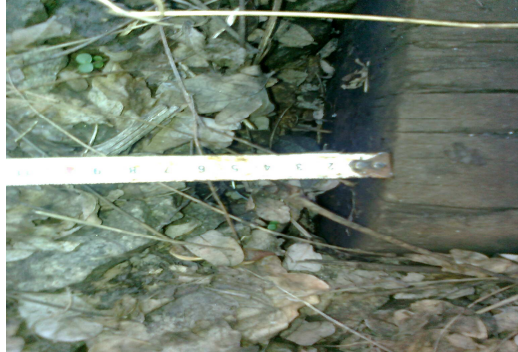
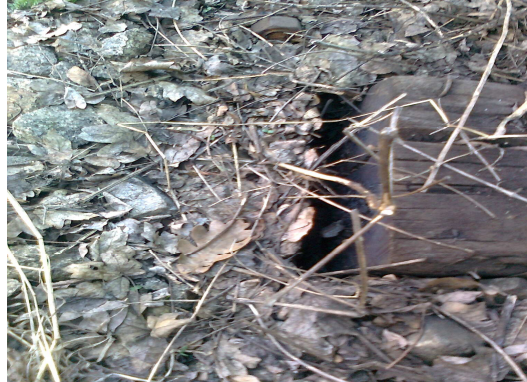
Between the place located at 10 m before the wheel fell and the stopping of the train, as a result of its dynamic action on the line, this was scraped of the locomotive with measured values between 40 mm and 60 mm towards the right line, in the running direction, so the values of the track deflection were affected and their interpretation has no relevance.

Photo 6: • Scraping of the track
