MINISTRY OF TRANSPORTS AND INFRASTRUCTURE
ROMANIAN RAILWAY AUTHORITY - AFER

ROMANIAN RAILWAY INVESTIGATING BODY

INVESTIGATING REPORT

of the railway accident occurred on 30.08.2012 on the Regional centre for railway operation,
maintenance and repairs București,
in the railway station București Triaj, Switch cabin 17

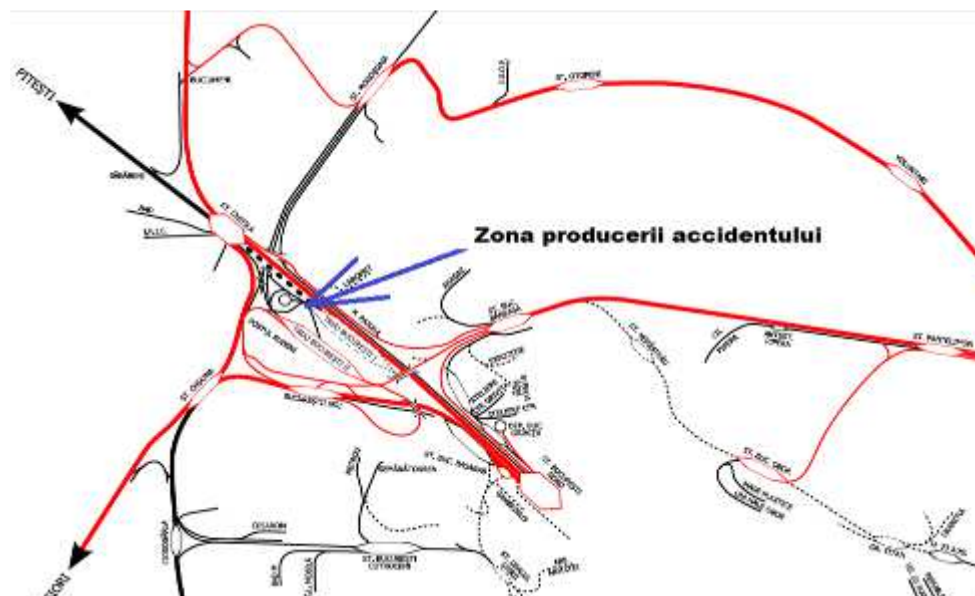
Photo no.1

when, passing over the switch 23, the second bogie in the running direction derailed, from the 9th wagon in the train, from the locomotive.

The accident site – photo 1.

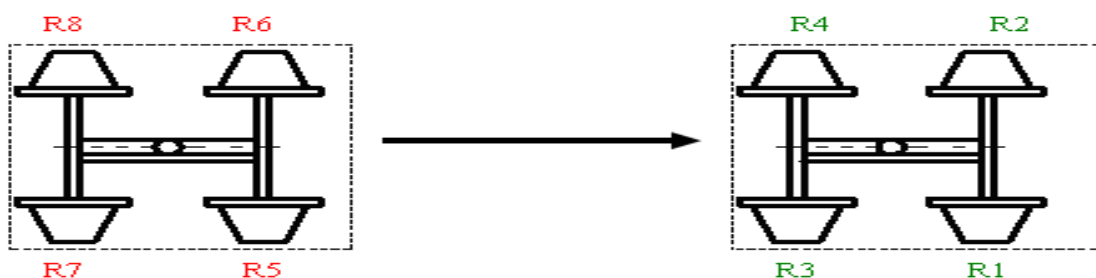
Figure no.4

- the second bogie, in the running direction, derailed by both bogies;
- Lenoir shock absorber ineffective at the axle journal no.7;
- the buffer from the end of the wagon without hand brake corresponding to the axle journal no.8 tear out from the screws after the derailment;
- loss of lubricant at the axle-box cover of the axle journal no.6.
- the two bogies wheels were positioned with the odd axle journal on the right side and with the even ones on the left side, in the train running direction (figure no.4)

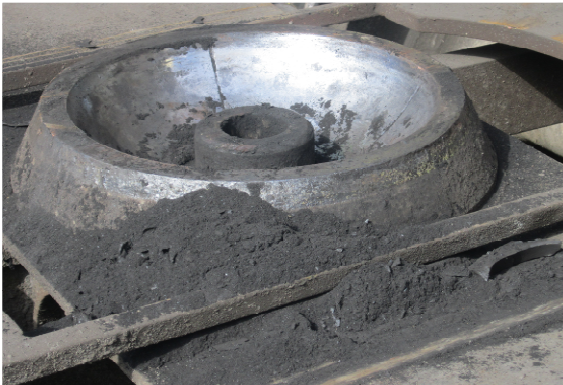
Figure no.2

- the polyamide plate at the derailed bogie centre casting was completely destroyed, grounded (turn to dust), material that was thrown outside the contact area between the upper and lower centre casting according to figure no.2 ;
- pronounced friction traces on the upper centre casting with damage to the geometric shape and spherical cap of the upper centre casting according to figure no.3 ;
- the rubber protection joint had compactions and permanent deformations most pronounced in two opposite areas;
- buffers corresponding to the axle journals no.3 and no.7 blocked not allowing the rotation of the plate, as well as wear on the plate.

At the wagon no. 81536653788-5 one found failures in operating the centre casting from bogie no.2 which had the effect of entering in direct contact of the upper centre casting with the lower centre casting with significant damage to the adhesion coefficient and the appearance of asymmetric wear at the upper centre casting, which directly influenced the derailment.

The malfunction of the centre casting was possible due to the total destruction of the weariness fitting, made of material type polyamide, by grinding and thrown outside the weariness fitting from the contact area upper centre casting – lower centre casting, which had the effect of entering into direct contact of the upper centre casting with the lower centre casting with significant damage to the adhesion coefficient and the appearance of asymmetric wear at the upper centre casting.
