INVESTIGATING REPORT

of the railway accident
occured on 19.04.2012 between the railway stations Augustin and Racoș in the Regional center for
railway operation, maintenance and repairs Brașov

*Final report
23rd of August 2012*

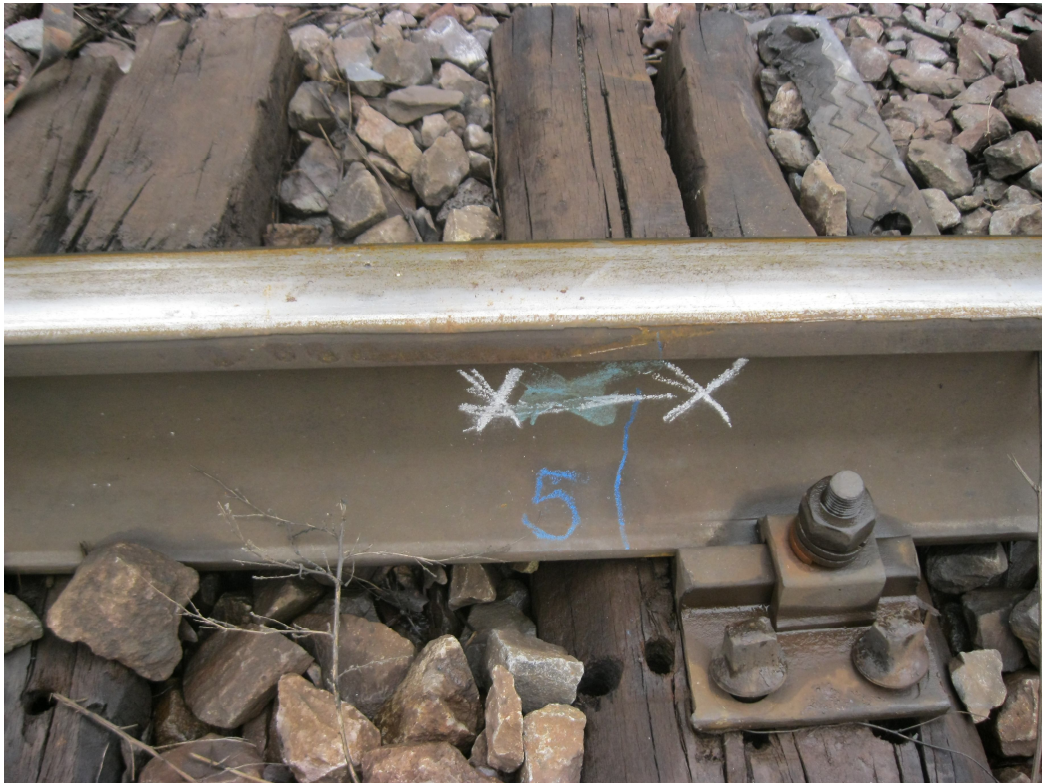
Between the railway stations Augustin and Racoş, on a curve area with right deviation, in the area of km 227+787 occurred the fall of the right wheel from the first axle in the running direction between the rails, its movement with the tyre active surface on the vertical screws inside the line and between the tyre lateral side and the rail active lateral surface was a friction over a distance of 16,15 m - *photo no.1.*

photo no. 1 – fallen wheel traces on the right side between the rails

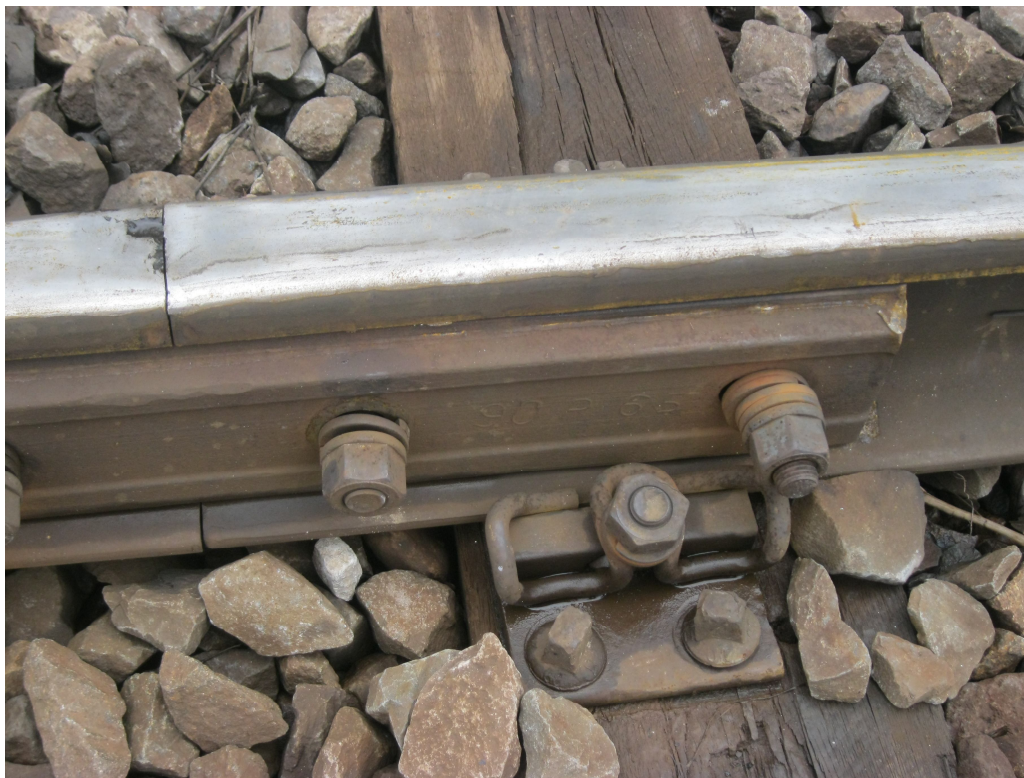
Reaching the joint at km 227+803,5 the right wheel from the wagon first axle hit the upper fishplate shoulder from inside the line, runned with the flange of wheel on the fishplate shoulder and fell between the rails after it has passed.

photo no. 2 – hitting the fishplate and the tyre running on it

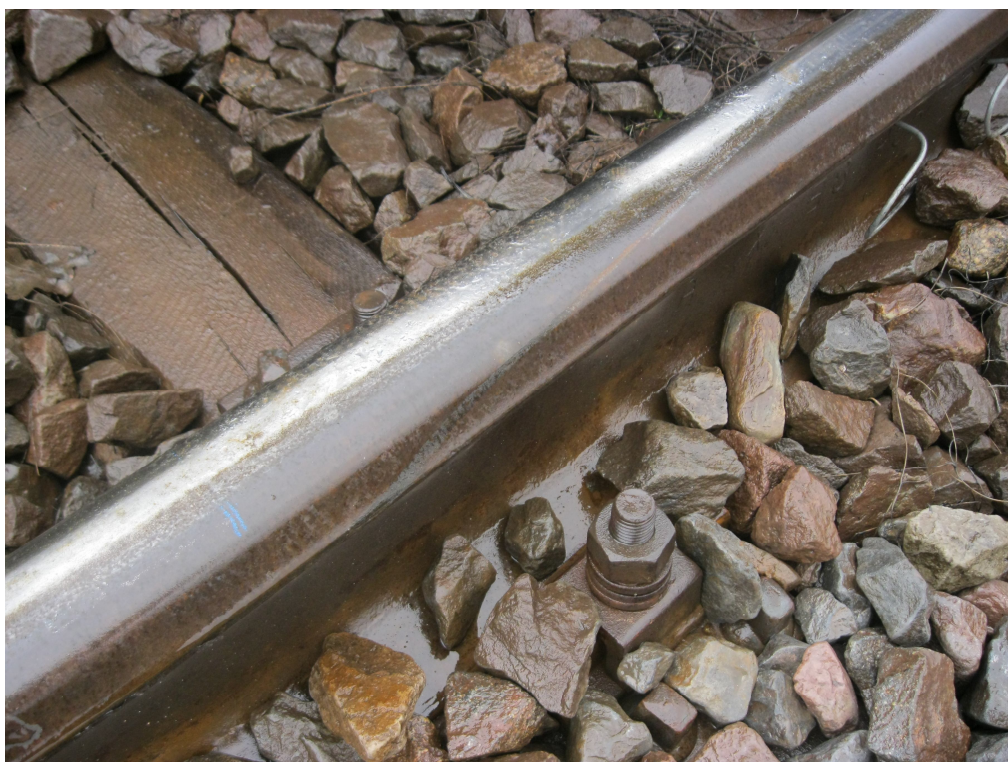
During this time, the left wheel from the first axle in the running direction runned in normal conditions until the right wheel hit the upper fishplate shoulder. At that time, on a distance of 0,95 m from the joint, the left wheel climbed the rail to the exterior of the line, runned on the head of rail on a distance of 0,42 m (*photo no. 3*), after which it fall on the exterior vertical screws (*photo no.4*).

photo no. 3 – climbing and the fall of the left wheel

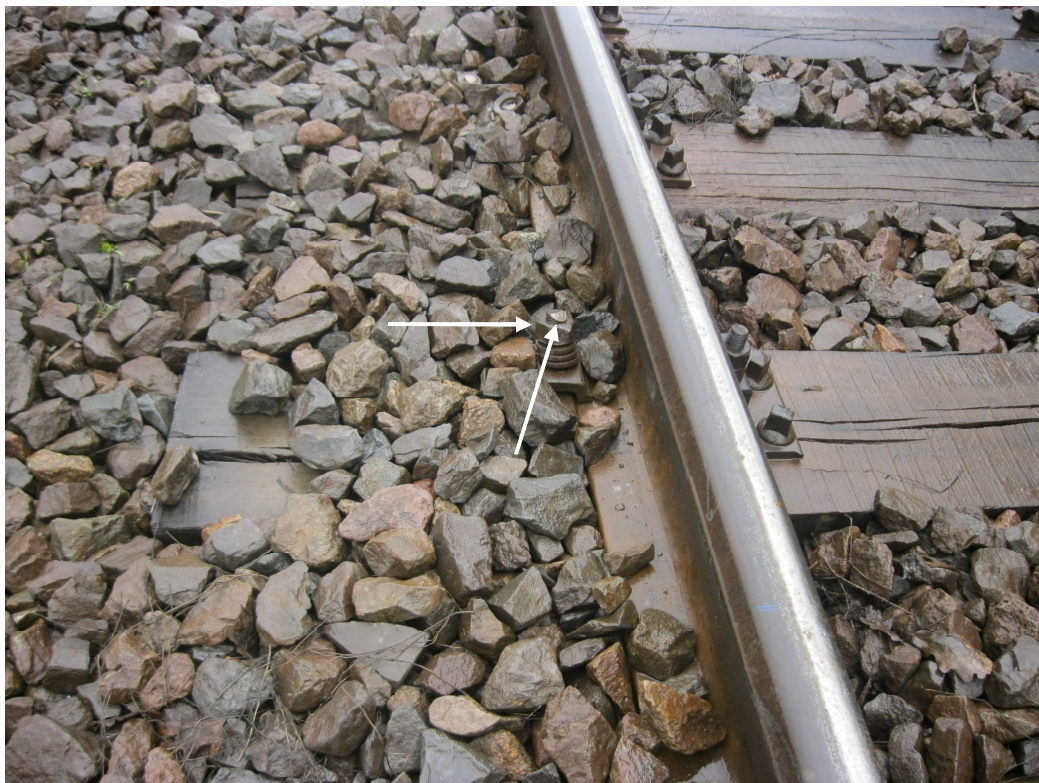
photo no. 4 – the first bolts from the exterior of the line hit by the left wheel

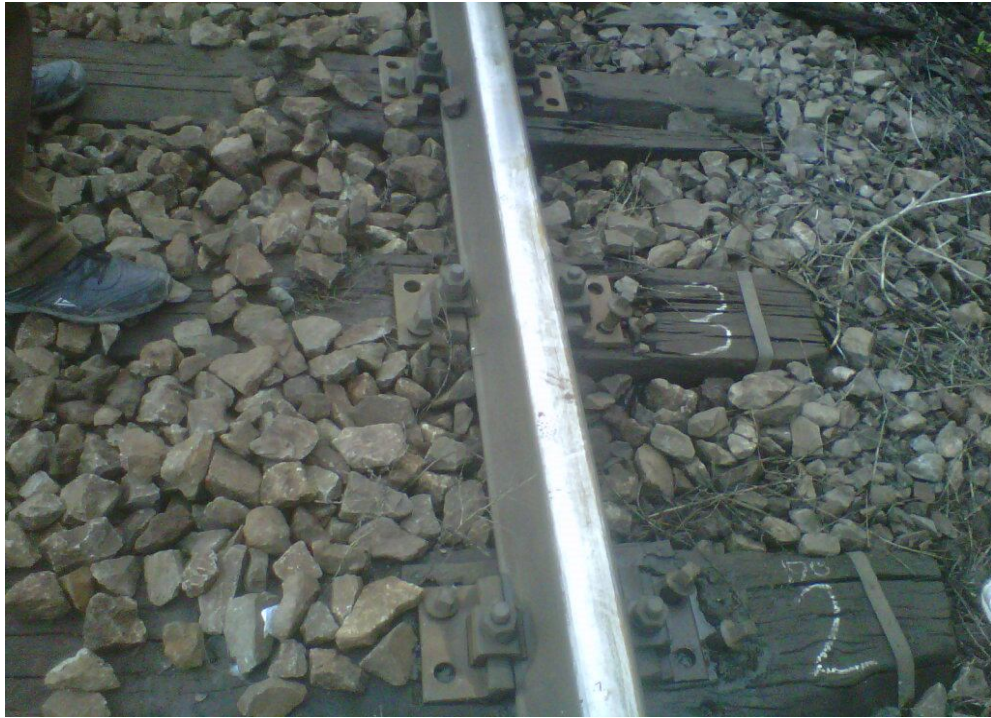
- the second sleeper,– the metal plate from the end of the sleeper corresponding to the inner stretch of rails of the curve had only 2 coach screws;
 - the third sleeper - the metal plate from the end of the sleeper corresponding to the inner stretch of rails of the curve had only 2 coach screws, and on this end one observed a trace corresponding to a lateral displacement of the metal plate, the metal plate displacement measured at this sleeper end was of 18 mm – *photo no. 5*;

photo no. 5 – fastenings in the area before the accident

The inappropriate technical condition of the wooden sleepers didn't allowed the coach screw tightening for fixing the metal plates on the sleepers, facilitating their lateral movement under the action of hotizontal guiding force from the wheels to the rolling stock.

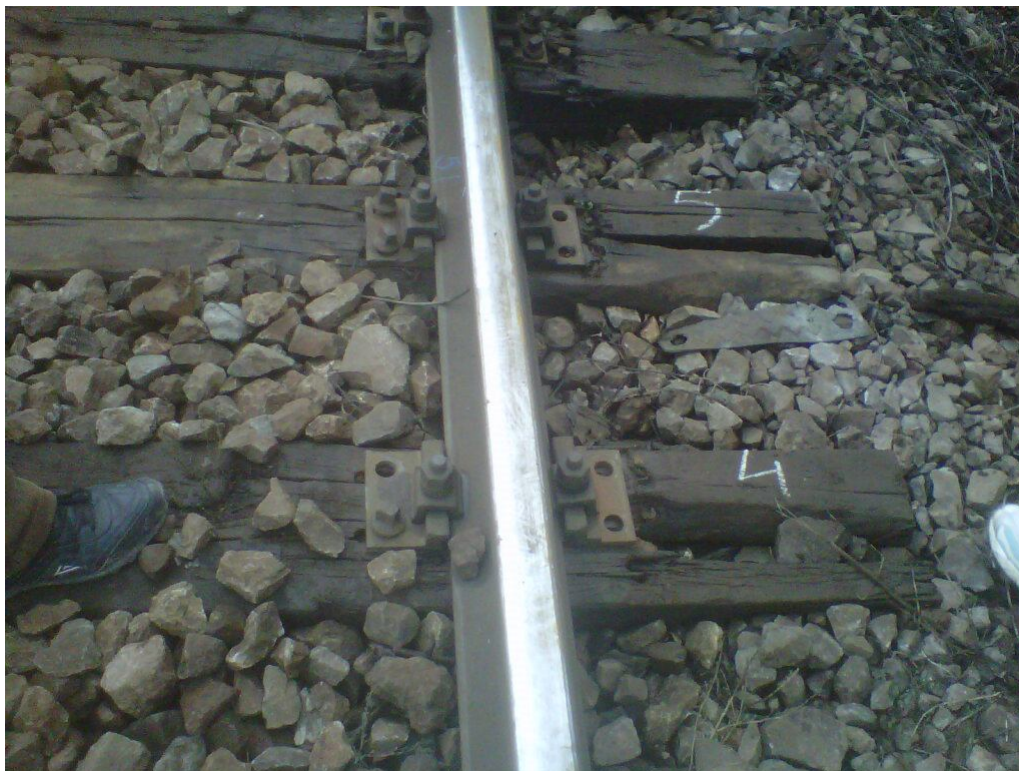
- the fourth sleeper - the metal plate from the end of the sleeper corresponding to the inner stretch of rails of the curve had only one coach screw, and the trace of the metal plate displacement on the upper surface of this sleepers end was of 15 mm – *photo no. 6*;

- the fifth sleeper (the place where the wheel fall between the rails) - the metal plate from the end of the sleeper corresponding to the inner stretch of rails of the curve had only 2 coach screws, but neither one fixed the metal plate on the sleeper– *photo no. 6*.

photo no. 6 – fastenings and sleepers in the accident area (sleeper no.5)

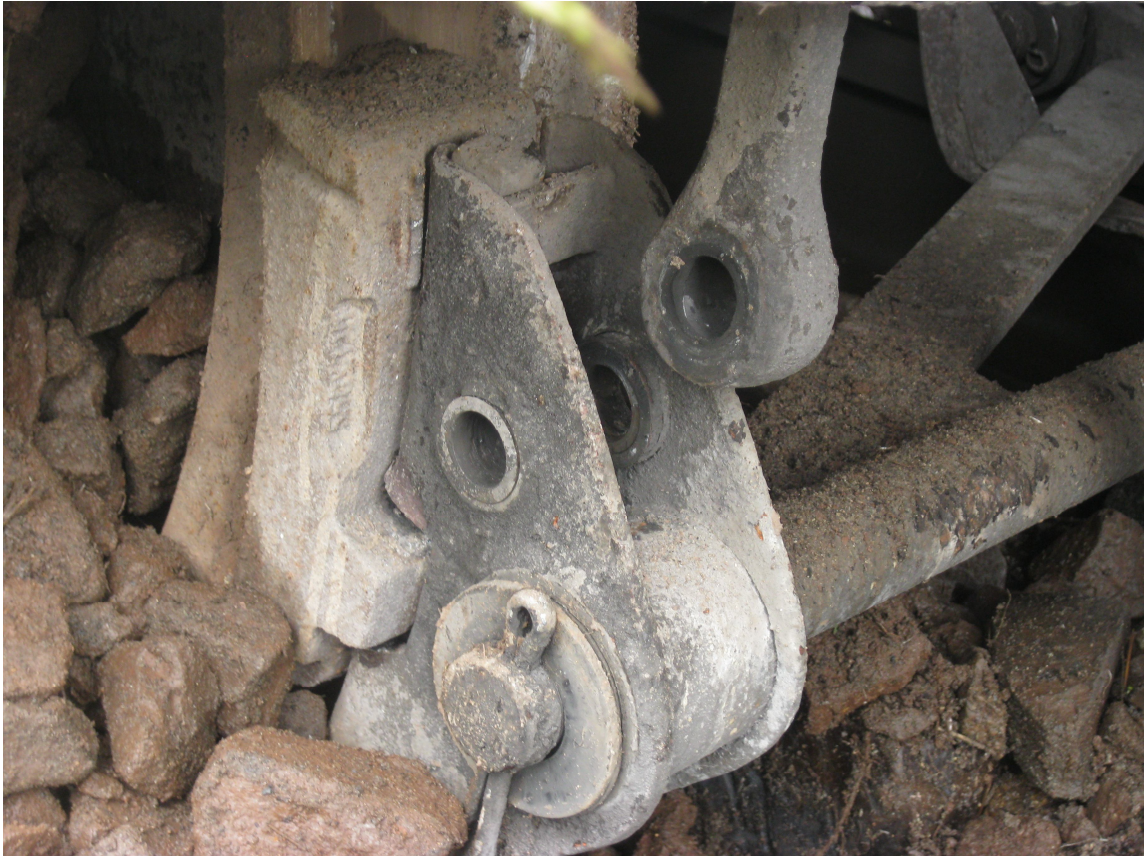
- the wagon was derailed by the first bogie in the running direction, (the bogie with the wheels 1-2, 3-4), the wheels 1-3 on the right side and the wheels 2-4 on the left side in the running direction;
- the brake hanger pin from the inferior brakeblock holder from wheel no.4 left in the running direction from the interior missing, with recent use traces – *photo nr. 7*;

photo. no. 7 – inferior brakeblock holder wheel no.4

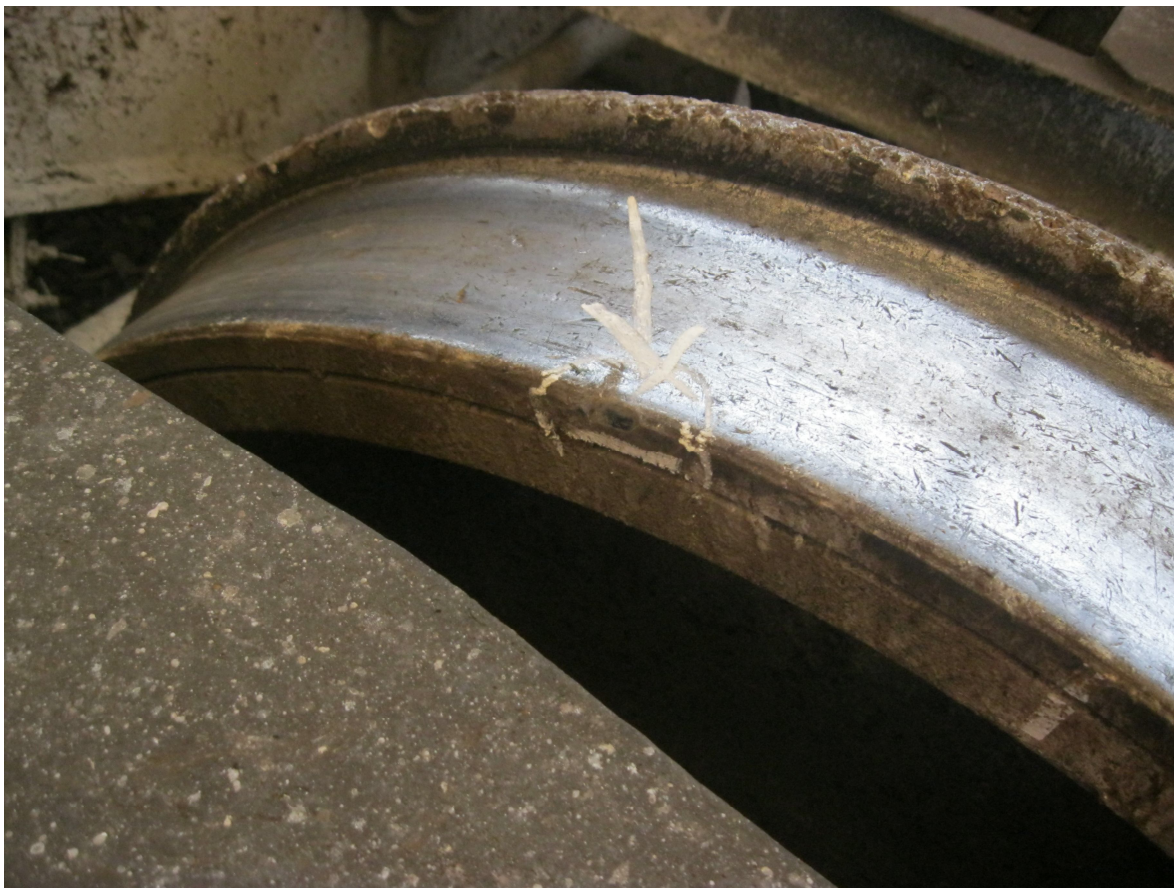
- the friction blocks clearance are within the limits of the instructions;
- at the derailed bogie, the corresponding plate, whole and non-cracked, one found two broken safety stirrup-piece (new breaks) at the axle journal 2 (front) and 4 (back) against the direction of traffic;
- wheel no. 1, first in the running direction on the right side, had a trace on the cast wheel edge, trace resulted from the impact of this wheel with the interior fish plate that had hit traces in the wheel no.2 climbing area – *photo no.8;*

photo no. 8 – trace on the wheel no.1 edge
