MINISTRY OF TRANSPORTS AND INFRASTRUCTURE
ROMANIAN RAILWAY AUTHORITY - AFER

INVESTIGATING REPORT

on the railway incident
occured on the 8th of September 2009 in the railway station Ilva Mică

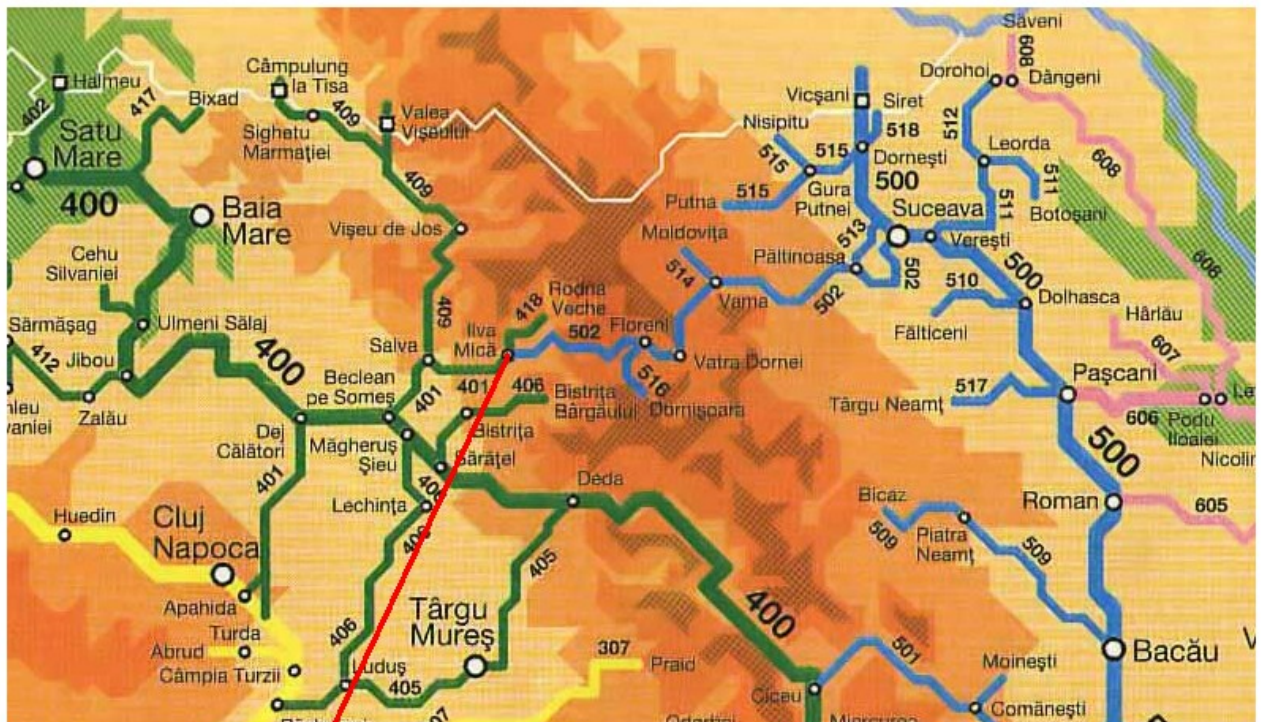
locul producerii incidentului

After separating the sleeping car according to the passenger-train composition list, the train was dispatch from the railway station Vatra Dornei at 19:20 o'clock and running until the entry in the railway station Ilva Mică where it had the order for stabling at line 6.
