MINISTRY OF TRANSPORTS AND INFRASTRUCTURE  
ROMANIAN RAILWAY AUTHORITY - AFER

ROMANIAN RAILWAY INVESTIGATING BODY

## INVESTIGATING REPORT

on the railway accident  
occurred on the 19<sup>th</sup> of June 2011 between the railway stations CFR Timisul de Sus - Predeal  
on the range of activity of CF Brasov Regional Branch

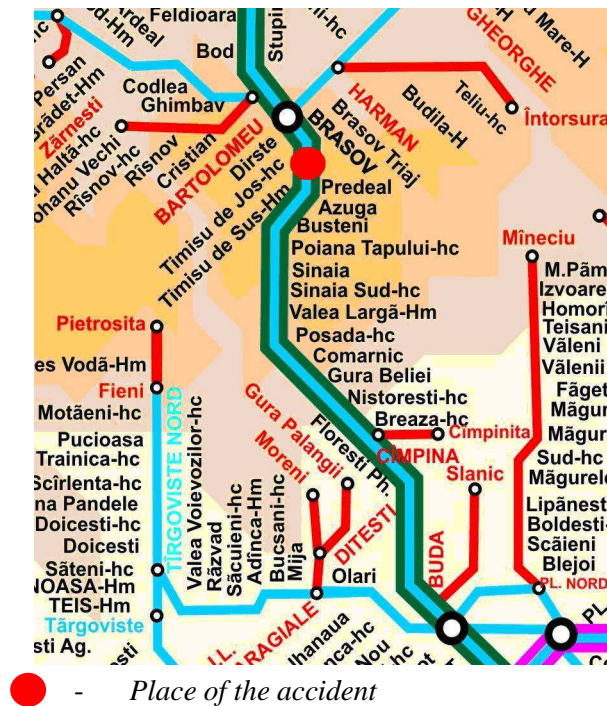
Around 11:16 a.m. between the railway stations CFR Timisul de Sus - Predeal, on the running wire I at the km. 150+825 (curve with left deviation in the running direction of the train) occurred the derailment outside the curve of the first bogie in the running direction of the wagon no. 81536656119-0 (the 12<sup>th</sup> by the locomotive), the wagon running derailed up to the km. area of 150+300.

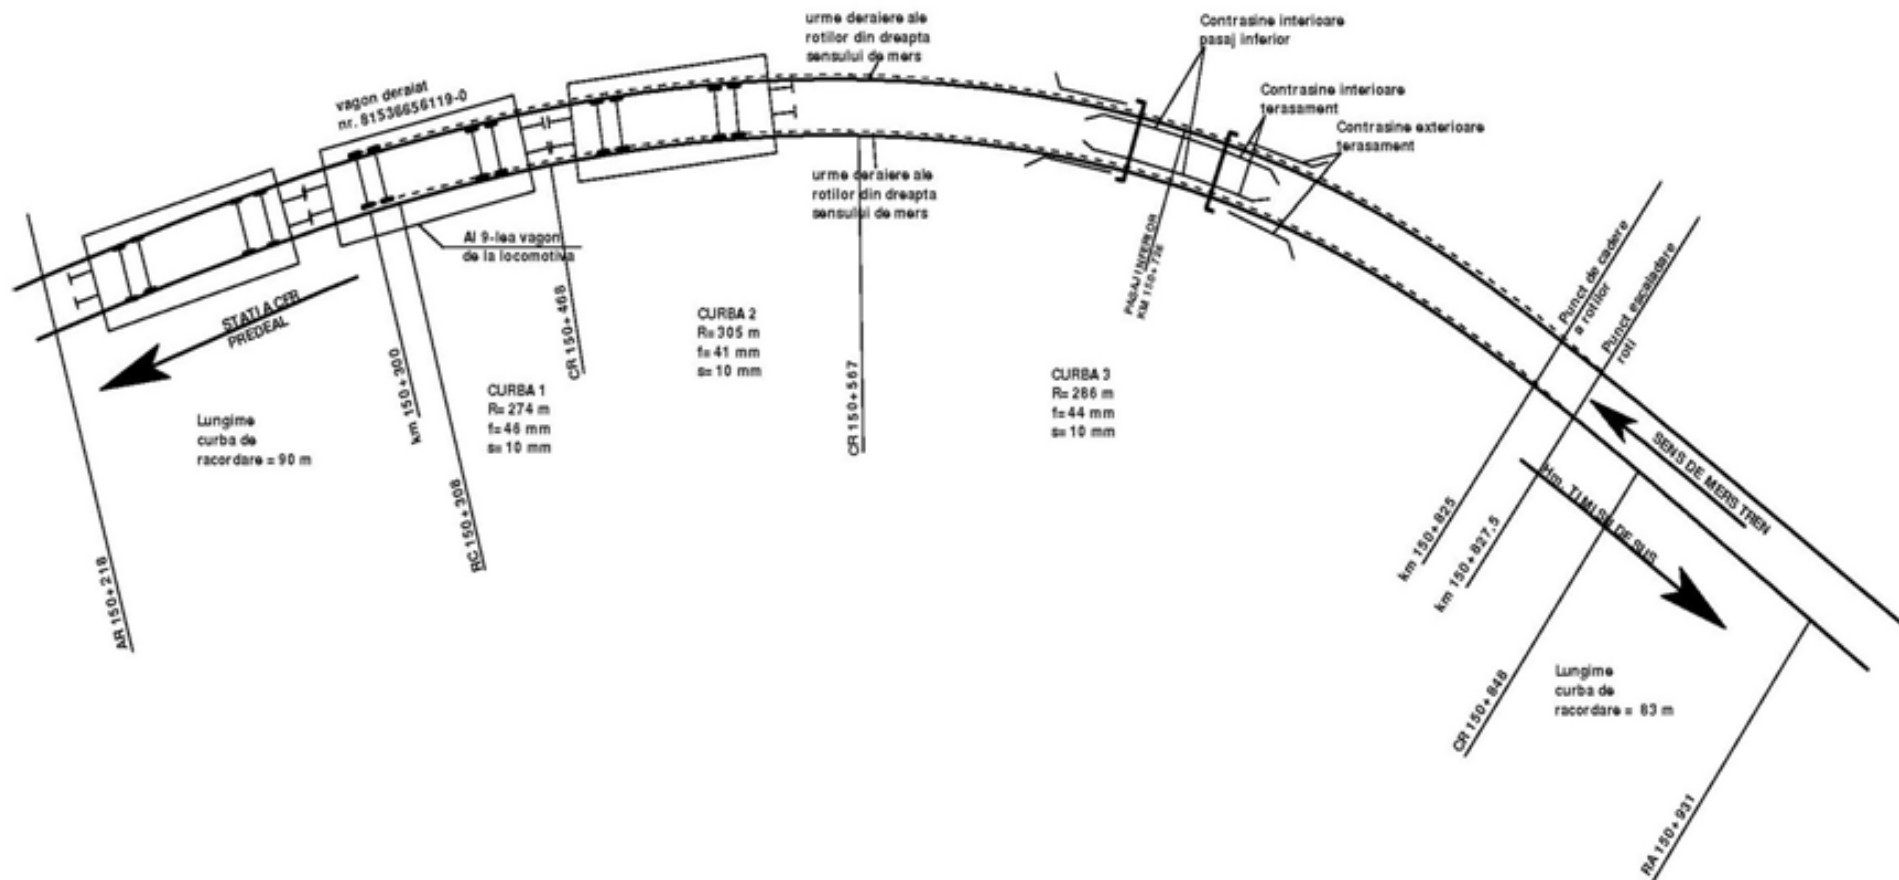
After check of the gauge (E) and of the cross level of the path (N) performed with the rail measuring pattern and of the curve arrows by measurement in the middle of the chord of 20 m, there was not found the exceeding of the tolerances admitted by the *Instruction of standards and tolerances for the construction and maintenance of the rail - standard gauge lines* no. 314/1989, for the running speed of the line.

After check of the vertical and side wears of the rails there was not found the exceeding of the values admitted by the same instruction.
