INVESTIGATING REPORT

of the railway accident
occured on 19.04.2012 between the railway stations Augustin and Racoș in the Regional center for
railway operation, maintenance and repairs Brașov

*Final report
23rd of August 2012*

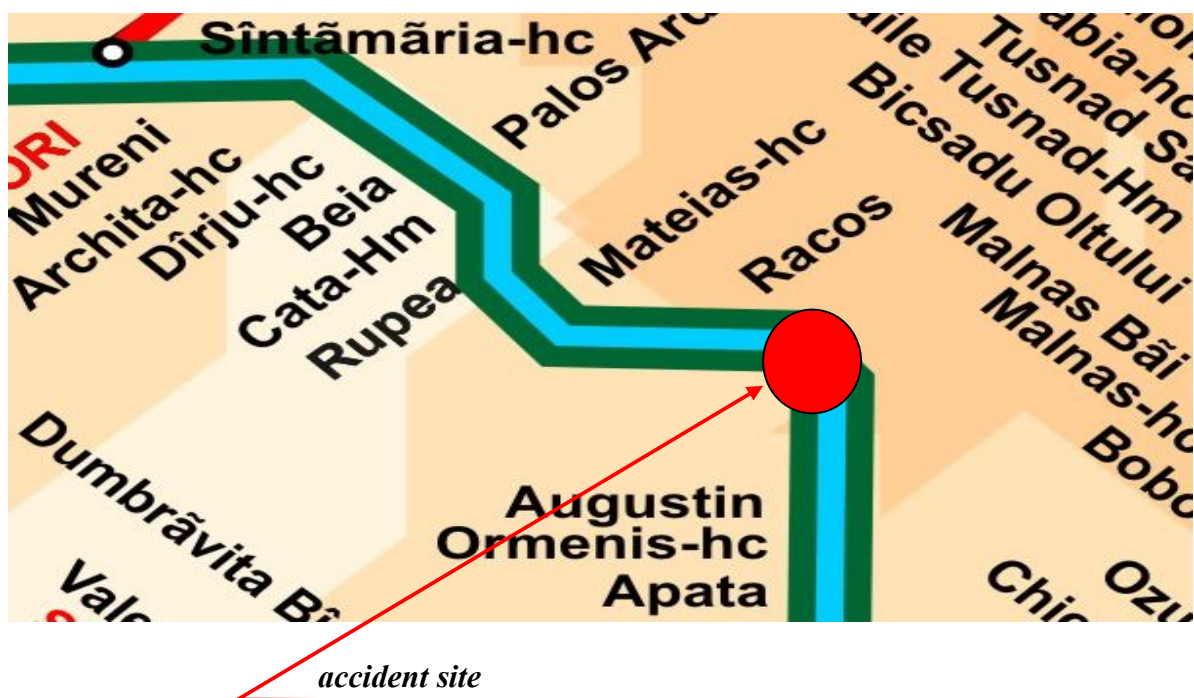
Between the railway stations Augustin and Racoş, on a curve area with right deviation, in the area of km 227+787 occurred the fall of the right wheel from the first axle in the running direction between the rails, its movement with the tyre active surface on the vertical screws inside the line and between the tyre lateral side and the rail active lateral surface was a friction over a distance of 16,15 m - *photo no.1.*
